Building Inspection Report

-----, VT

Inspection Date:
08/07/2013

Prepared By:
Burlington Home Inspection Service Ltd.
137 Mansfield Ave.
Burlington, VT 05401

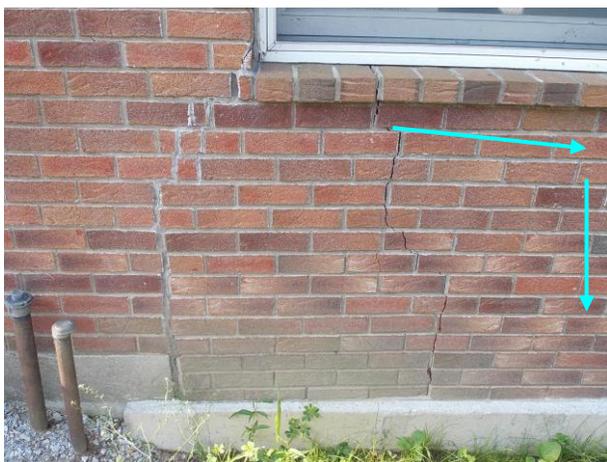
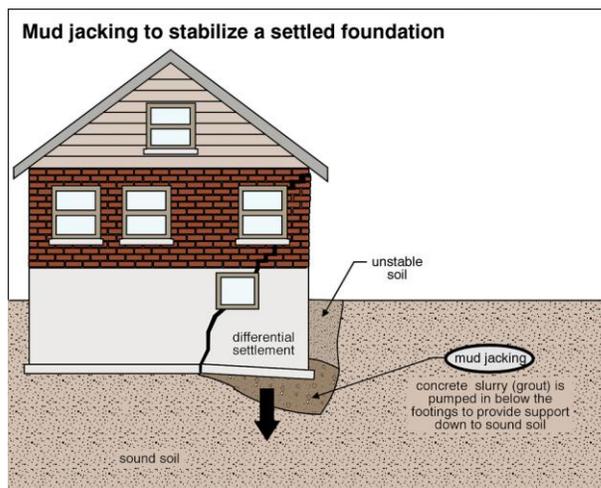
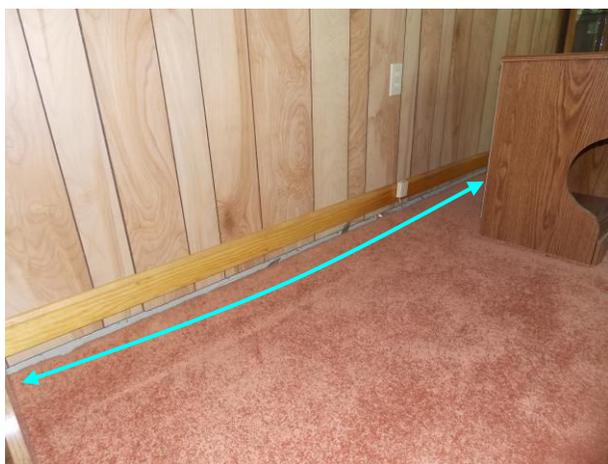
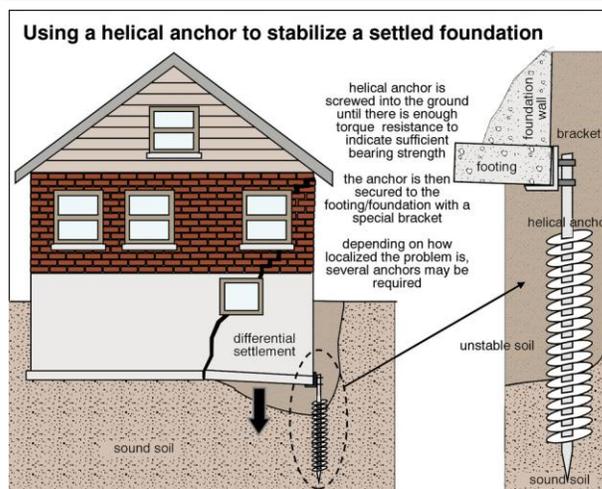
- **Major Concern:** Substantial foundation settlement cracking was observed in the rear addition. Structural movement of the building has occurred. Since repairs are needed to protect the building from more serious damage, a geotechnical engineer or a structural engineer who is familiar with foundation repair or a company specializing in foundation repairs should be consulted to evaluate the condition and to suggest corrective measures. The rate of movement cannot be predicted during a one-time inspection.

In this case, repairs have been attempted in the form of a concrete buttress poured next to the original wall but do not seem appropriate to this application where settling seems to be the main issue. Connection to the original building is a secondary issue. The floor has obviously pulled away and sagged as seen from the interior.

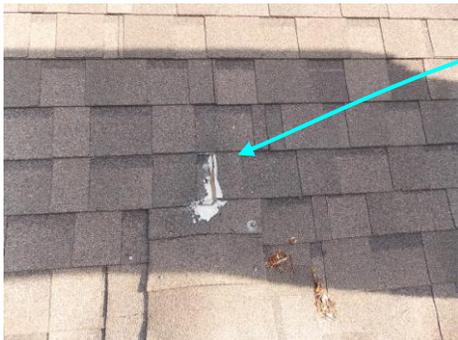
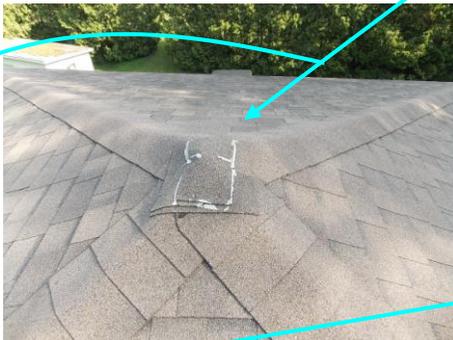
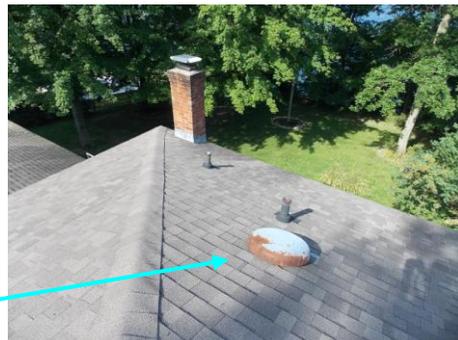
- **Monitor:** The hip/ridge shingle is vulnerable in two locations, because it is sealed with caulk which will dry out and crack. It should be watched carefully for leaks.

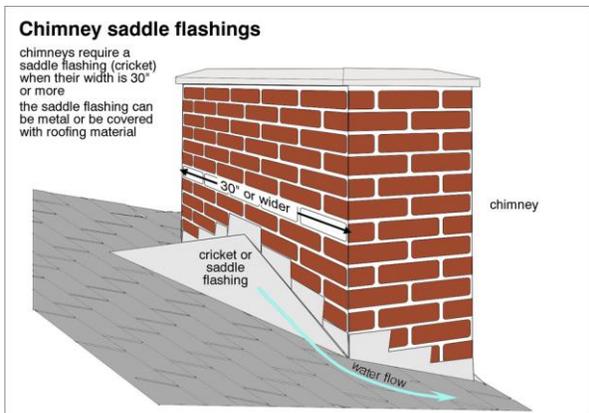
A 'Cricket' or rain/water diverter could be installed on the upper side of the chimney. This will reduce the chances of a leak here.

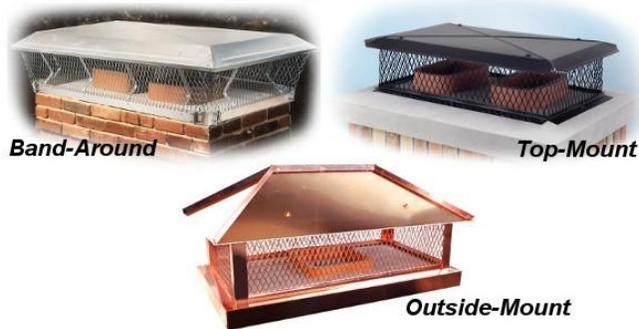
The installation of a metal roof with vermin screen on large chimneys is a logical improvement.

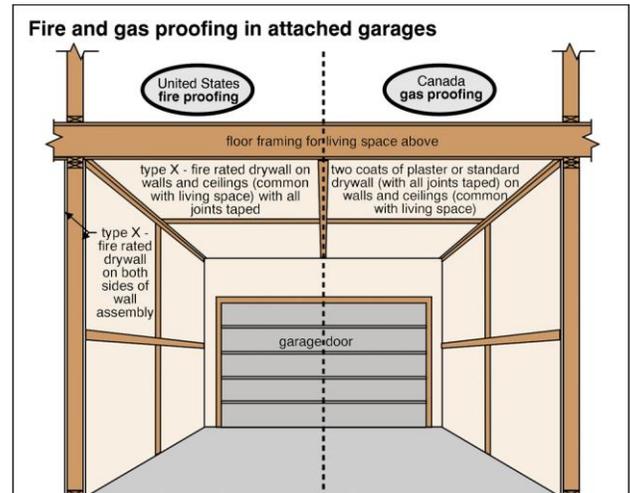
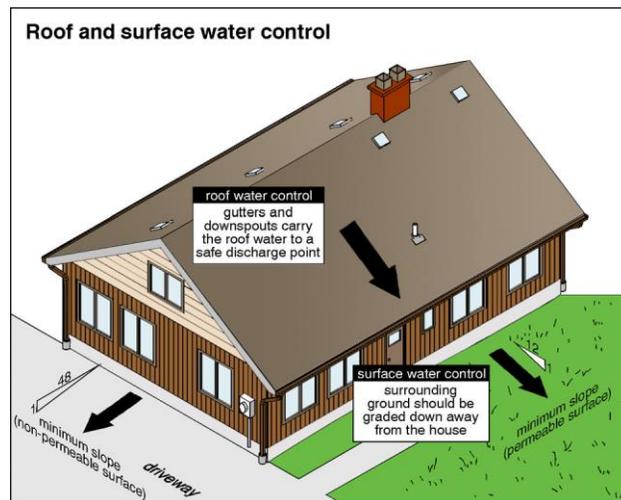
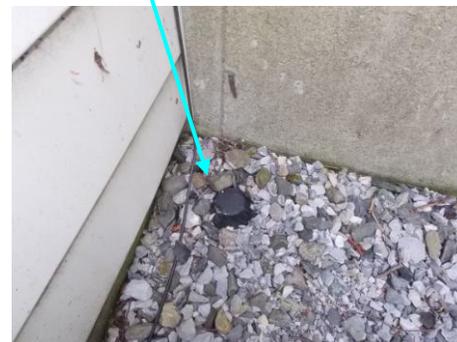
- **Improve:** The driveway slopes towards the house at the front wall. This condition can promote moisture seepage and/or icing in winter. Unfortunately, it is difficult to improve this situation without resurfacing the driveway adjacent to the foundation. A qualified mason, carpenter, or paving contractor can perform this work.
- **Monitor:** An exterior 'Perimeter Drain' or 'Footing Drain' apparently exists. This item carries water away from the base of the foundation. In this case, the pipe is unusually small and may prove to be for another purpose. Recommend maintaining the cap on top. The exit pipe (usually found at the low point on the lot) should have a vermin screen. Recommend periodic flushing with water and monitoring the end of this pipe.

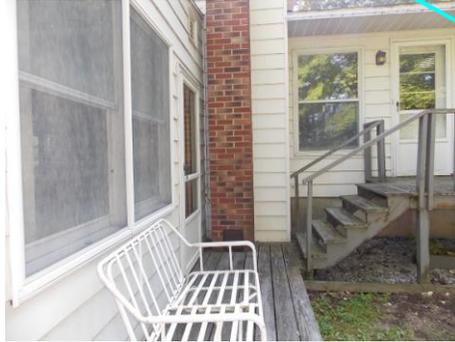
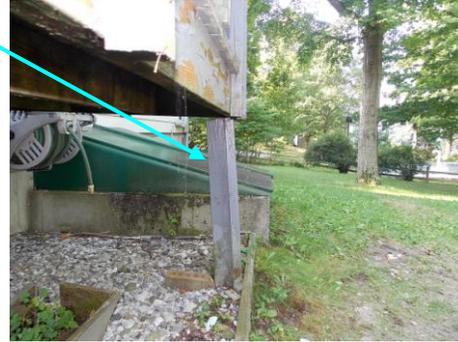
- **Repair:** The support posts for the deck are poor. A footing extending at least 3-4 feet below grade level would be installed. Wood/soil contact should be avoided. A qualified carpenter should correct this.

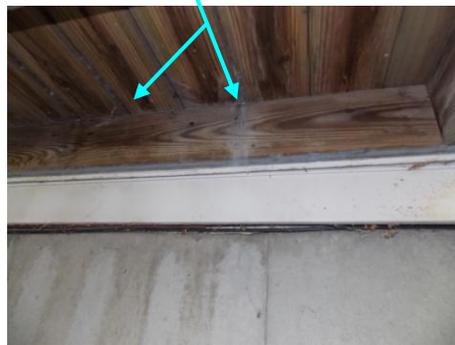
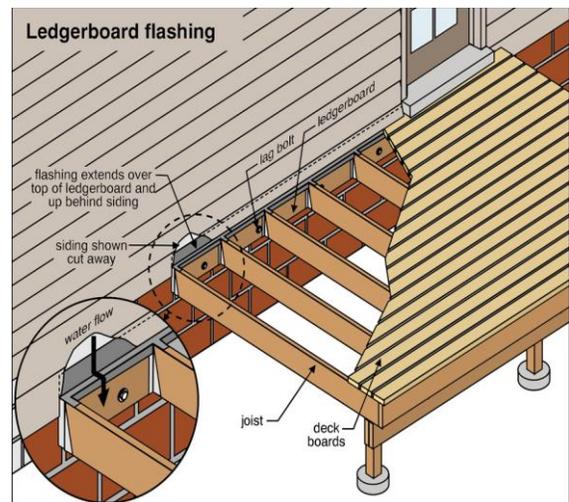
- **Safety Issue:** The deck should be cleaned of algae and painted or stained to improve durability. A deck with algae is very slippery when wet.
- **Safety Issue:** As there is a danger of falling, an improved railing should be provided for the steps at the rear wall. The openings in the deck railing are large enough to allow a child to fall through. It is recommended that this be corrected for improved child safety. A qualified experienced carpenter should perform this work.
- **Repair:** A proper flashing should be provided at the intersection of the exterior wall of the house and the deck at the rear wall. This will help avoid water penetration and eventual rot. A qualified carpenter or contractor can perform this work.

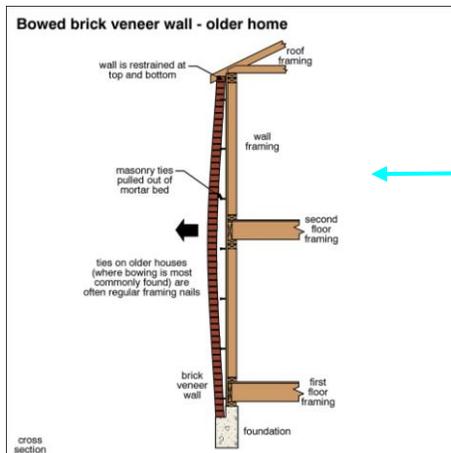
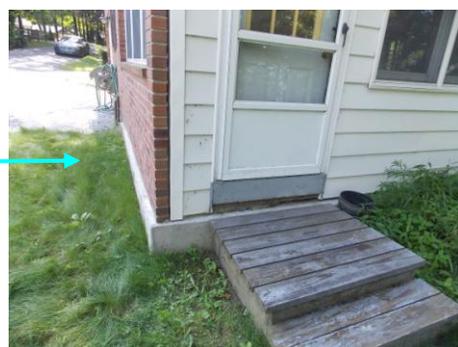
- **Repair:** Damaged brickwork should be repaired after foundation repairs are complete to preserve the wall. A qualified mason should perform this work.

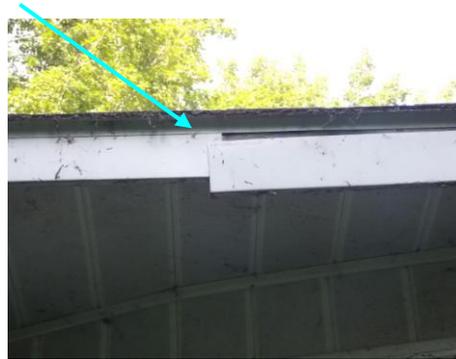
- **Repair:** The fascia (trim around the roofline) is loose at the front slope. It should be secured. A qualified carpenter or siding contractor should perform this work.
- **Safety Issue:** Bee nests were noted in various locations. A qualified exterminator should be consulted.

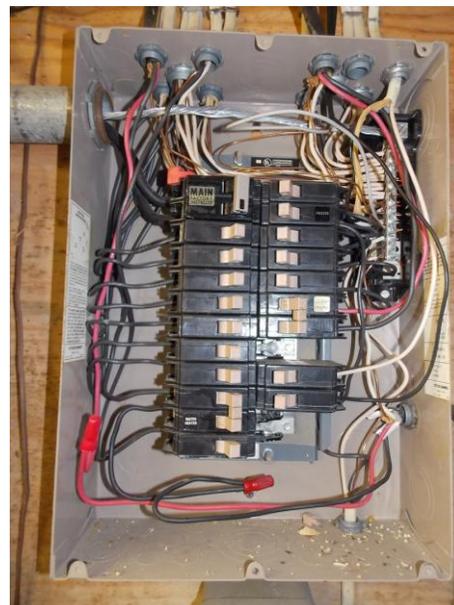
- **Improve:** The panel circuits should all be clearly and accurately marked by an electrician.
- **Repair:** Any openings in the auxiliary panel should be covered.
- **Safety Issue:** Neutral and ground wires within the auxiliary distribution panel that are doubled up should be separated. A separate bus connection should serve each.
- **Monitor:** Evidence of mice living in the panel was noted. This should be cleaned up. Any openings in the panel should be covered.
- **Repair:** Circuits within the distribution panel that are doubled up (referred to as “double taps”) should be separated. A separate fuse or breaker should serve each circuit.

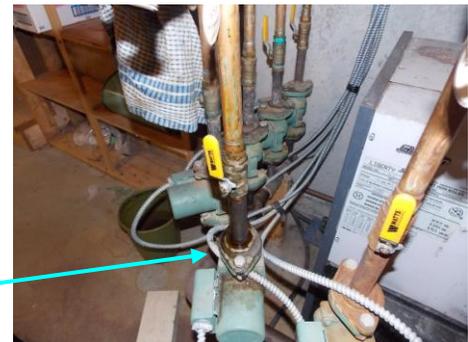
- **Repair, Safety Issue:** For safety reasons, it is recommended that the Temperature and Pressure Relief (TPR) Valve extension be conventionally installed for the water heater. *The current arrangement is a safety concern. The pipe is combined with the water heater PRV valve and travels an unusual distance to a floor drain. This configuration would likely not contain the temperatures and pressure involved in a pressure relief event. In addition the pipe is disconnected near the tank in a dangerous location should it need to go off.* See also **Water Heater** – page 23
- **Repair:** A leak was observed at the circulation pump. Leaks at heating equipment should be repaired promptly to avoid damage to the equipment or to the building and to assure reliable system operation.

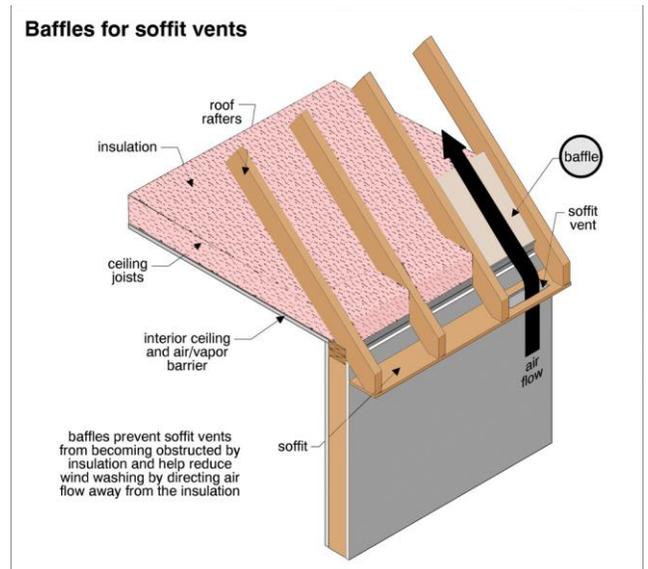
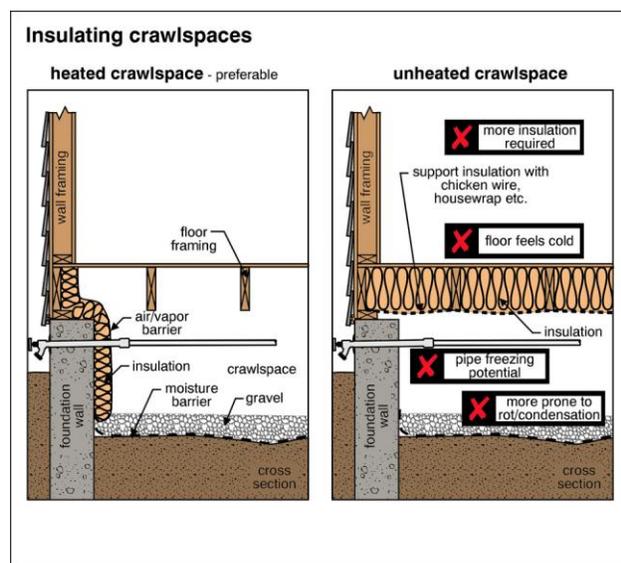
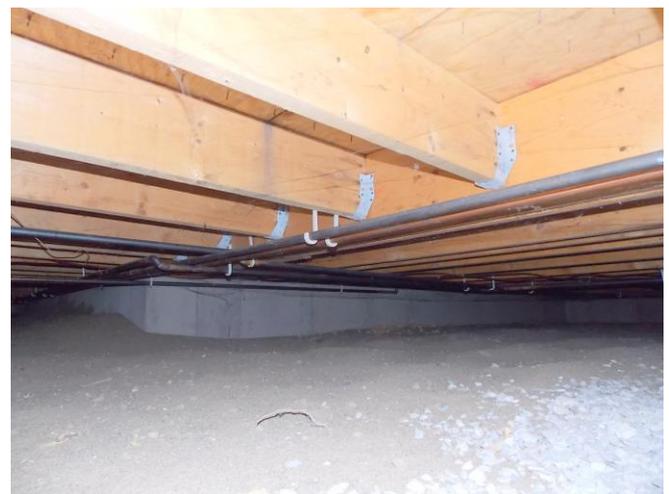
- Insulation improvements to the crawl space may be desirable to save energy costs, increase comfort level and prevent plumbing from freezing:
 - **Repair:** Insulation improvements are needed in the west crawl space floor. The fiberglass is wet, hanging down, and ineffective, and an invitation to vermin. At the least it should be replaced.
 - **Improve:** It would be wise to better insulate around the perimeter of the crawl spaces in place of insulation in the floor.
 - **Improve:** A moisture barrier should be installed on the crawl space floor. Mildew, rot, and ineffective floor insulation can result from excess moisture in this space. Recommend an insulation specialist install one. It should be installed so that it covers all areas of exposed soil and sealed to the walls.

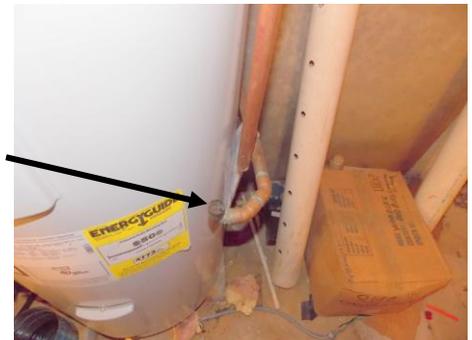
- **Repair, Safety Issue:** For safety reasons, it is recommended that the Temperature and Pressure Relief (TPR) Valve extension be conventionally installed for the water heater. ***The current arrangement is a safety concern. The pipe is combined with the boiler PRV valve and travels an unusual distance to a floor drain. This configuration would likely not contain the temperatures and pressure involved in a pressure relief event. In addition the pipe is disconnected near the tank in a dangerous location should it need to go off.***

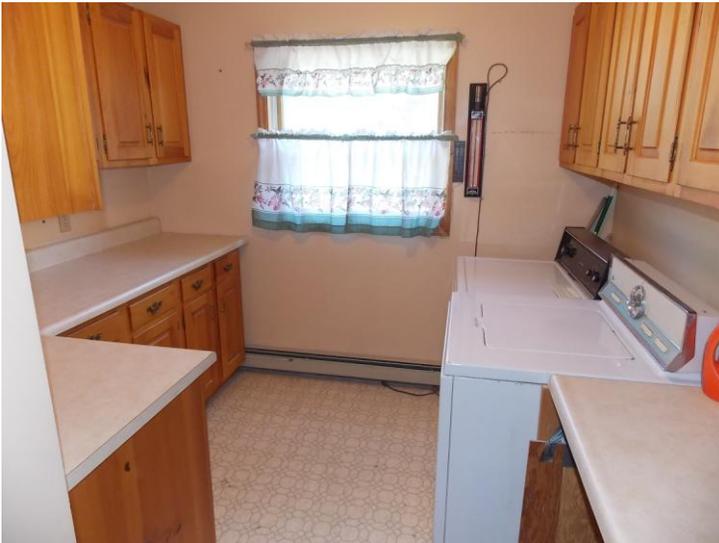
'Flexible steel hoses' are recommended for the washing machine to reduce the possibility of a broken or burst hose. Washer hoses are under pressure (if not turned off) and can cause extensive damage when they burst.
