Building Inspection Report

----- Road, Essex, VT

Inspection Date:
11/05/2011

Prepared By:
Burlington Home Inspection Service Ltd.
137 Mansfield Ave.
Burlington, VT 05401

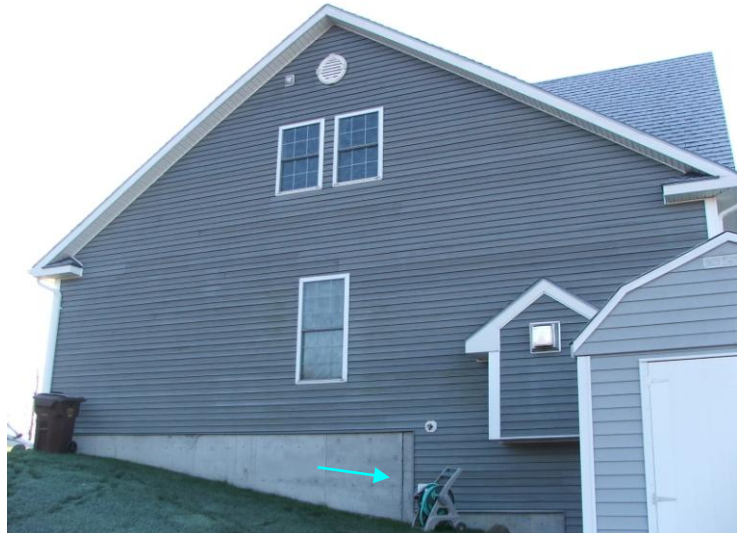
- **Monitor:** Settlement and cracks were observed in the north foundation wall adjacent the foundation joint. This implies that some structural movement of the building has occurred. Cracks of this type should be watched for any sign of additional movement. In the absence of any sign of ongoing movement, repair should not be necessary.

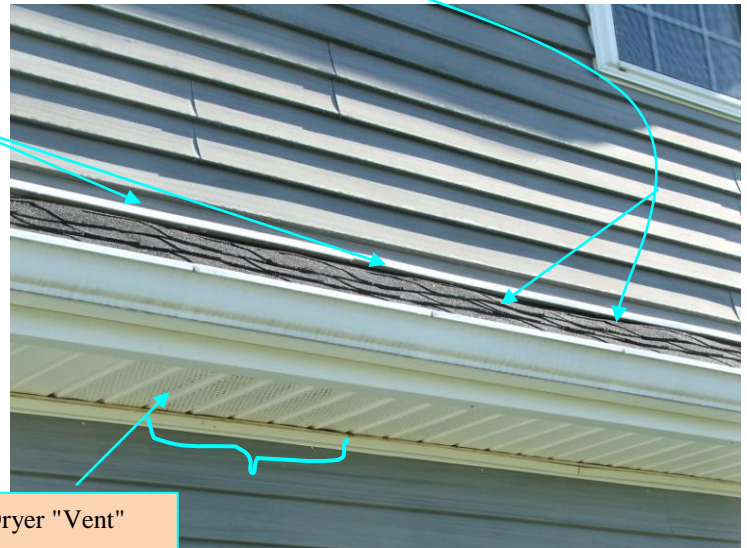
- **Repair:** Rippled areas were noted on the rear return roof. This is suspected to be from warped sheathing. This, in turn is likely from the dryer venting into the return. Moisture damage could be present. recommend further investigation and any repairs deemed necessary. See also **Flashings** – below; **Dryer** - page 26 and **Exterior Eaves** - page 11

- **Repair:** The roof/wall flashing along the west return section is damaged and should be repaired to avoid leaks.
- **Monitor:** The installation of the roof/wall flashing is less than ideal. Step flashing does not appear to be present. This can cause damage to go unnoticed. Recommend professional repairs if needed.
- **Repair:** The roof/wall (step) flashing, at the front slope could 'leak or 'dribble' at the bottom of the roof/wall detail. It could be adjusted to include a 'kick out' flashing. A qualified experienced carpenter or roofing contractor should perform this work.

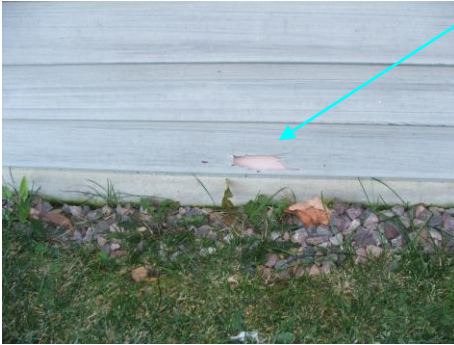
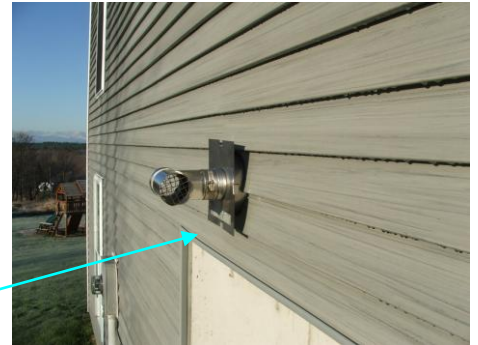
- **Improve:** Damaged/cracked and loose siding in a few locations should be repaired or replaced. A qualified experienced carpenter should perform this work.

- **Repair:** The siding is not properly flashed around exterior vents. A qualified, experienced siding carpenter can perform this work.
- **Safety Issue:** Bee nests were noted in various locations. A qualified exterminator should be consulted.

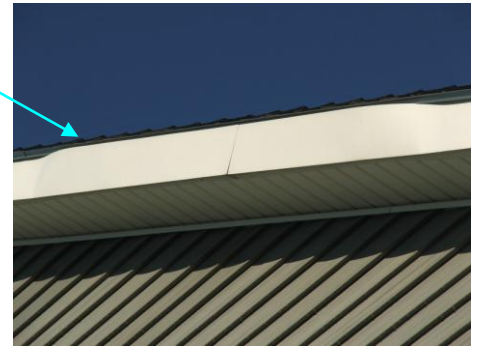
- **Repair:** The fascia (trim around the roofline) is loose at the south slope. It should be repaired to prevent wind damage and leaks. A qualified carpenter or siding contractor should perform this work.
- **Possible Safety Issue:** A partially blocked dryer exhaust arrangement was observed at the rear soffit/return. It should be vented to the building exterior. Blocked exhaust vents can be a fire risk. See also **Sloped Roofing and Flashing** - page 9

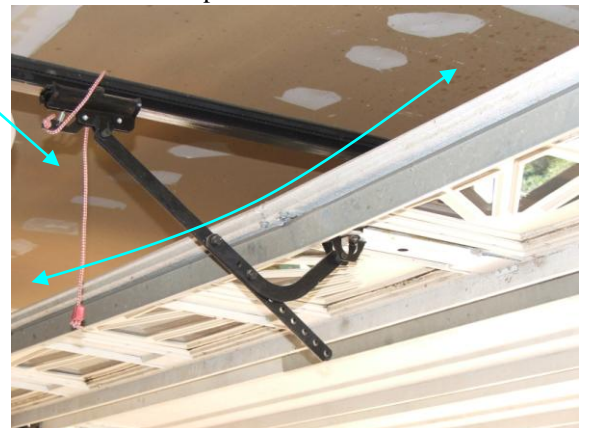
- **Safety Issue:** The overhead garage door is damaged and needs to be repaired or replaced. It could malfunction or even fall in its present condition. A qualified experienced overhead door contractor should perform this work.
- **Safety Issue:** The garage door opener did not automatically reverse under mechanical resistance to closing. A qualified overhead garage door technician should adjust it. See also Positive Observations above – *The infrared light...*
- **Monitor:** The slope of the garage floor is not conducive to good drainage. The slab appears to have settled. Improvement is not a priority but you should be aware improper slope risks sending water towards the building interior. Puddles can occur which can freeze.

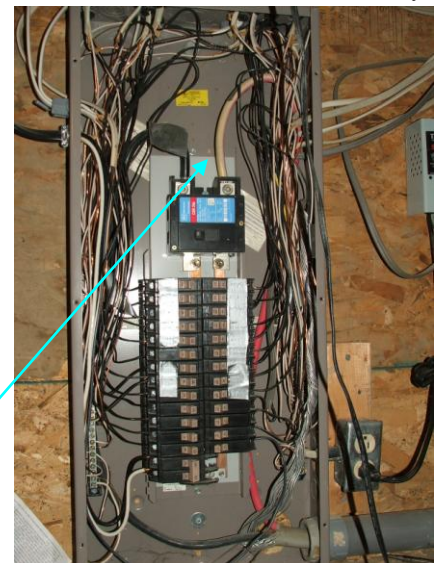
- **Monitor: Possible Safety Issue:** One of the main feeds is highly discolored. Overheated wiring within the main distribution panel should be examined by a licensed electrician and repaired as necessary.

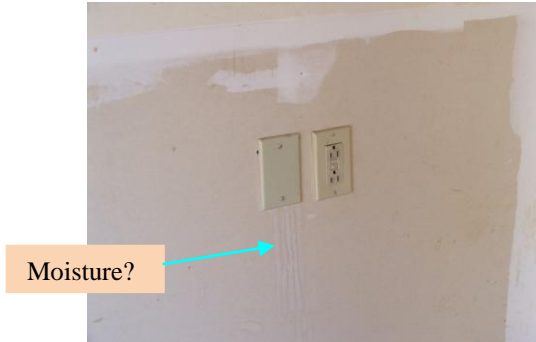
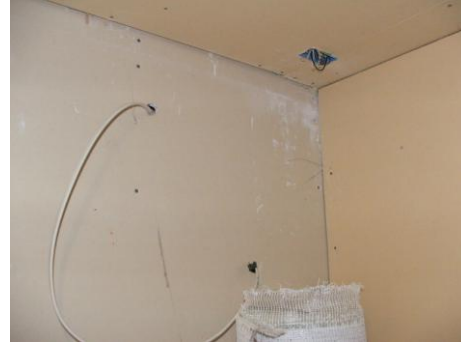
- **Safety Issue:** Unfinished wiring in the basement bathroom should be made temporarily safe from shock hazard until complete.

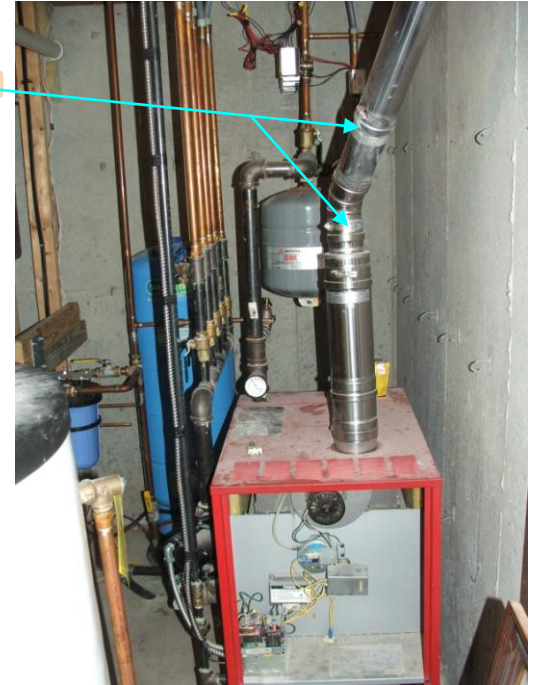
- **Safety Issue:** The exhaust vent clamps may employ gaskets that are known to deteriorate. The flue connection is somewhat loose. This condition should be evaluated by a qualified licensed heating technician right away..

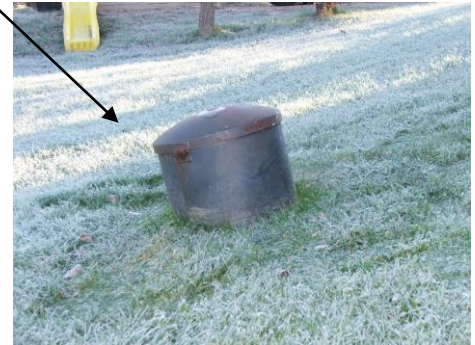
- **Repair:** The exterior hood of the propane gas tank is leaning badly. It could interfere with piping under this condition and cause a gas leak. The gas company should correct this right away.
- **Monitor:** Be mindful of the soft copper gas line leading from the tank to the home when digging, gardening etc.
- **Monitor:** A shut off valve could not be seen behind the dryer. The gas technician should install one if needed.

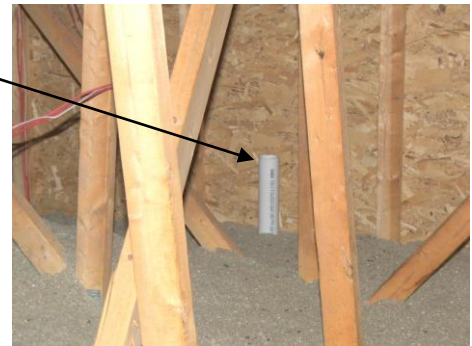
- **Repair:** Although all drains operated freely and no ‘suspicious’ areas were seen, heard or smelled outside, it is recommend the septic tank be cleaned and serviced by a qualified technician.
- **Repair:** The vent stack that penetrates to the attic should extend at least 12 inches above the roof and should be at least 2 inches in diameter.

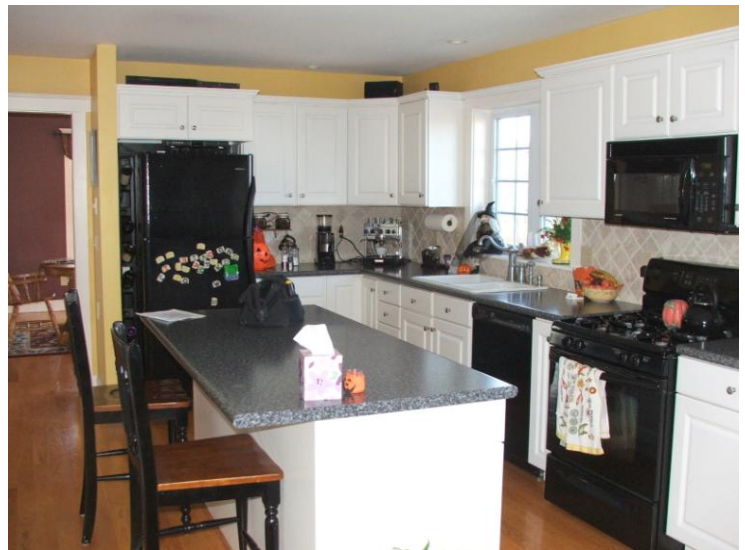
- **Potential Safety Issue:** An anti-tip device could not be seen behind the oven. One should be installed according to the manufacturer's directions. This will reduce the risk of tipping of the appliance from abnormal usage or by excessive loading of the oven door.
- **Safety Issue, Repair:** The gas range top is lower than the counter. This can burn the counter. It should be adjusted up according to the manufacturer recommendations. A qualified appliance repair technician should perform this work.
