Building Inspection Report

----- South Burlington, VT

Inspection Date:
08/29/2013

Report Number:
-----.0813

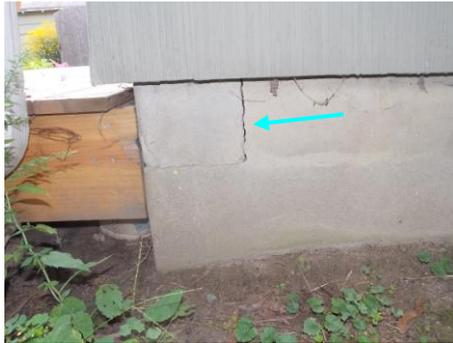
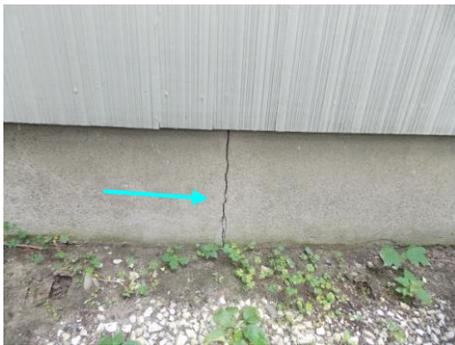
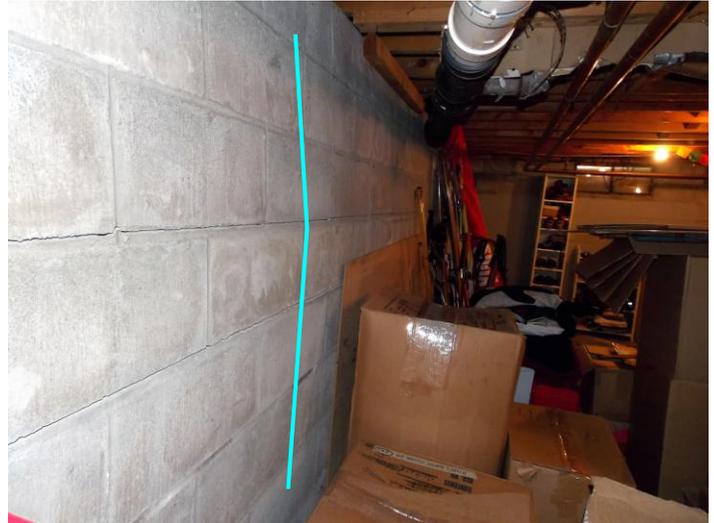
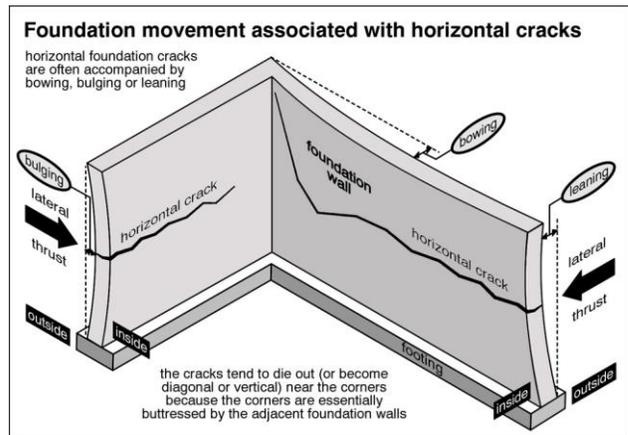
- Monitor:** Foundation bowing and cracking was observed in all walls however most pronounced in the east section. This is usually the result of excessive soil or frost pressure on the foundation. Lot drainage and foundation improvements should be addressed to keep water away from the building, and these cracks should be monitored. Recommend professionally filling these cracks. The rate of movement cannot be predicted during a one-time inspection. A structural engineer or qualified foundation repair contractor should be consulted to assess this condition and the remedies available for the east wall.

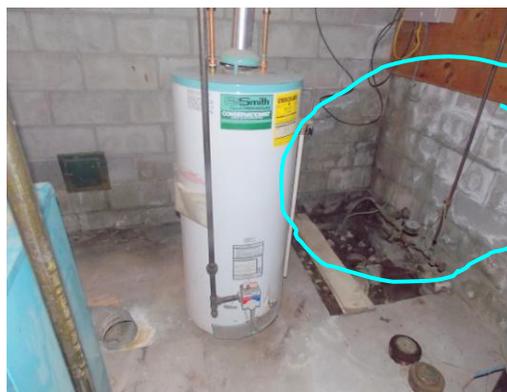
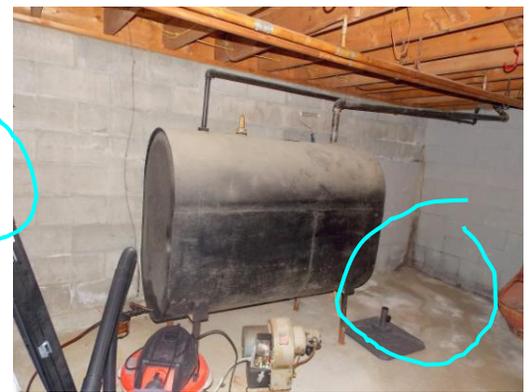
- Monitor:** The basement shows evidence of moisture penetration evidenced by: / Staining / watermarks – on the floor / efflorescence / elevated storage . Virtually all basements exhibit signs of moisture penetration and virtually all basements will indeed leak at some point in time. The visible evidence is above average for a home of this age, construction and location. Basement leakage rarely affects the structural integrity of a home but can cause other problems such as excess humidity and mold.

The vast majority of basement leakage problems are the result of insufficient control of storm water at the surface. Think of the home as sitting on top of the Pitcher's mound in Baseball. The ground around the house should be sloped to encourage water to flow away

Lot and roof drainage improvements should be undertaken as a first step. Excavation, damp-proofing and/or the installation of drainage tiles should be a last resort. In some cases, however, it is necessary.

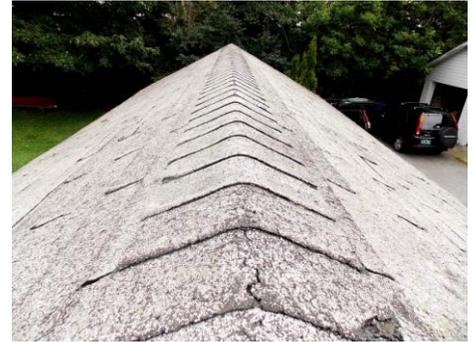
- **Major Concern, Repair:** The composition shingle roofing on the detached garage is at end of its life and should be replaced. A qualified experienced roofing contractor should perform this work.
 - It is recommended that the present layers of roofing materials be removed prior to re-roofing. This adds cost of demolition and debris removal to the re-roof cost.
 - Install proper roof flashing materials when re-roofing to avoid leaks in these areas.

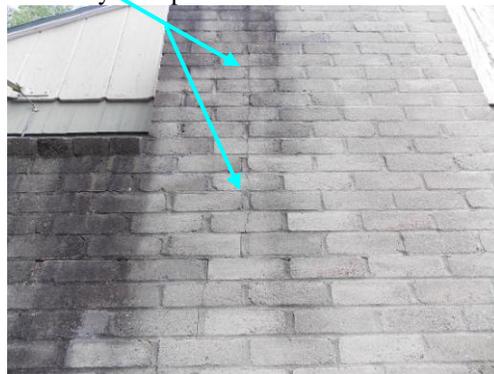
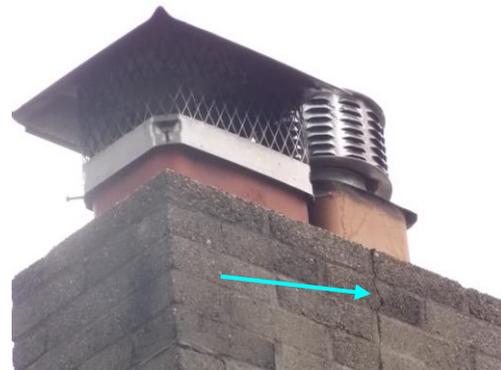
- **Repair:** The fireplace chimney flue should be swept and inspected by a C.S.I.A. certified chimney sweep before use. Have the Chimney Sweep check for any damaged flue tiles. Relining a chimney can be relatively expensive.
- **Monitor:** The chimney shows indication of movement evidenced by vertical cracking. Since chimney movement can damage the chimney's interior flue (an unsafe condition) you should have the chimney inspected by a qualified chimney sweep or mason.

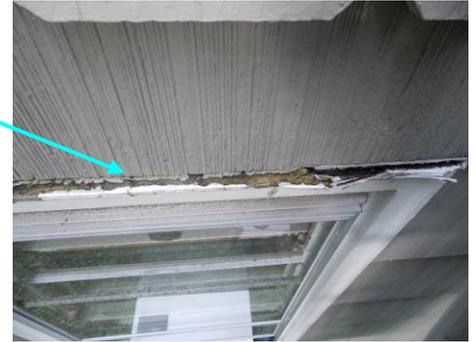
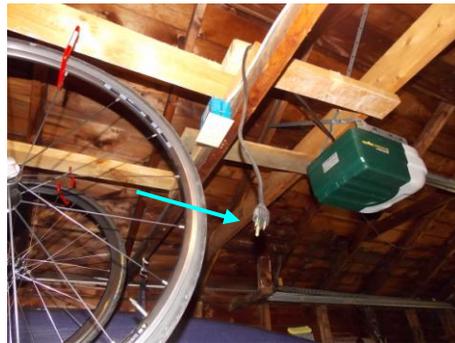
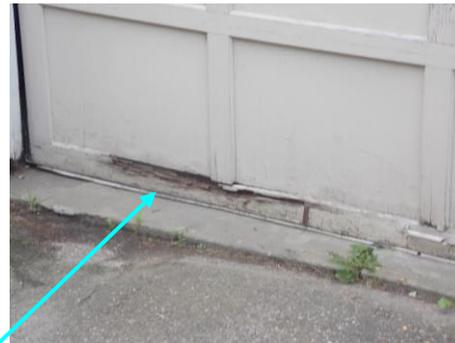
- **Improve: Safety Issue:** The garage door opener was disconnected at the time of the inspection. A qualified overhead garage door technician should be engaged. Upon reconnecting this unit, it should be tested. Proper operation of the reversing mechanism should be verified. *There is a serious risk of injury, particularly to children, under this condition.* Improvement may be as simple as adjusting the sensitivity control on the opener. This should be dealt with immediately.

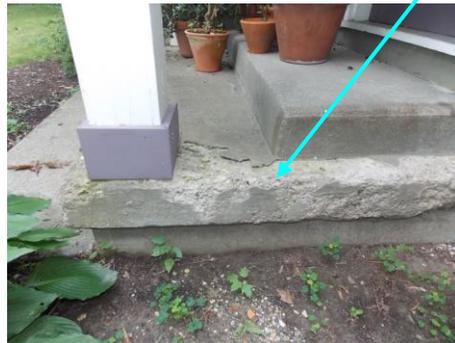
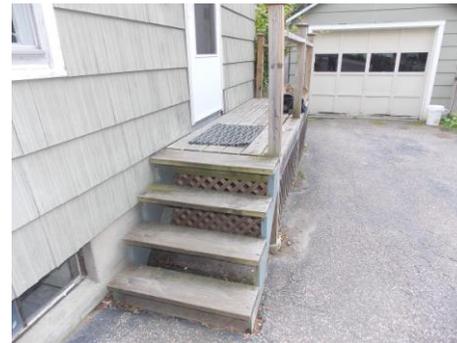
- **Deferred Cost:** The front porch masonry is deteriorating noticeably. Repairs or rebuilding are needed here and may involve significant expense. In the meantime, this stoop can be considered a trip hazard.

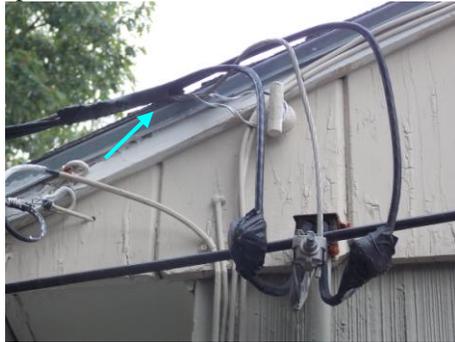
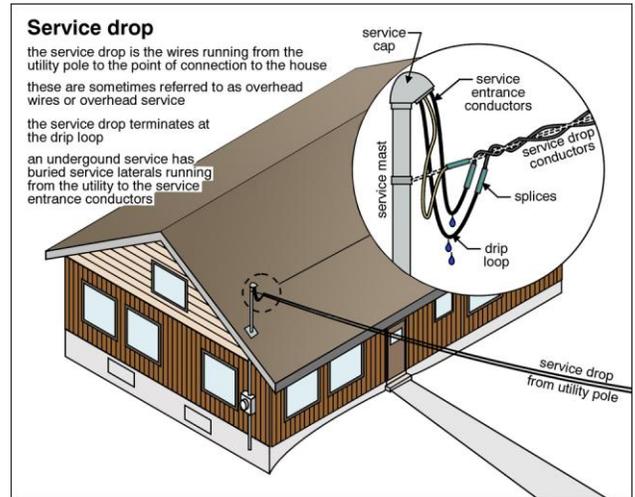
- **Improve:** The service wires do not have adequate clearance from the roof. The wires rub on the roof and could become "bare" to present a safety hazard. A service mast is typically installed to raise the height and form a better drip loop.

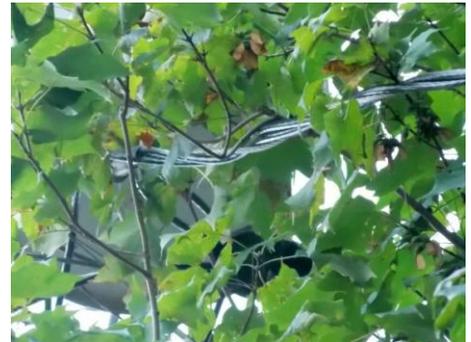
- **Repair:** The electrician should secure the loose meter.
- **Repair:** The service wires do not have adequate clearance from tree branches and are, in fact, touching the branches. The electric utility should be contacted for service.

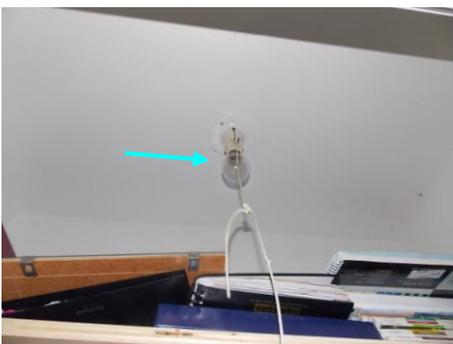
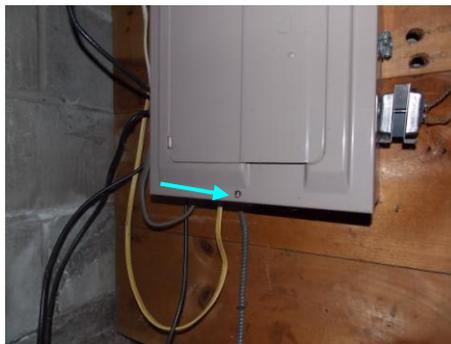
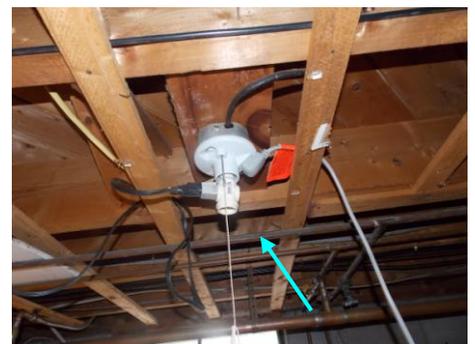
- **Safety Issue:** Extension cords or adaptors in the basement and any others found should not be used as permanent wiring. This wiring should be removed.
- **Repair:** Sloppy wire connections at the boiler should be improved. A qualified licensed heating technician or licensed electrician should perform this work.

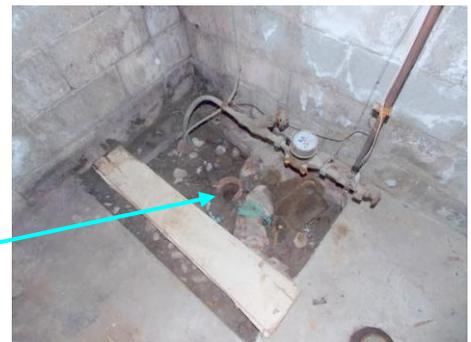
- **Repair:** Unsealed opening in the waste piping should be corrected.

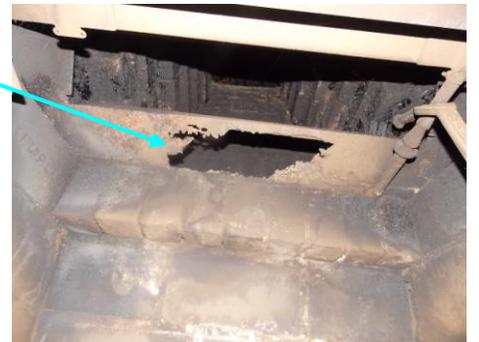
- **Repair:** The fireplace chimney should be swept and inspected by a C.S.I.A. certified chimney sweep prior to operation. It was observed to be dirty with deposits. See also **Chimney** – page 10
- **Repair:** Debris in the “clean out” area at the base of the chimney should be removed as part of system service.
- **Repair:** The fireplace damper is rusted away and requires repair.
