Building Inspection Report

----- **Essex, VT**

Inspection Date:
08/19/2013

Report Number:
-----.0813

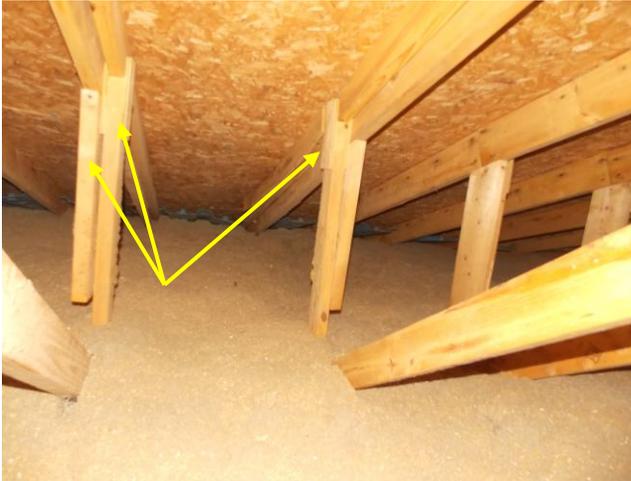
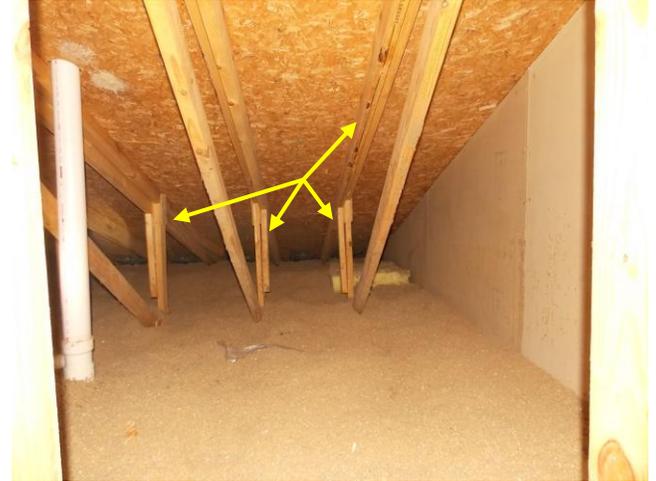
- **Monitor:** Some roof sheathing sags. This is common where roof trusses are spaced two feet apart, allowing sagging between trusses.
- **Monitor:** Prior repairs to the roof structure are evident. Roof trusses have been altered. They have been "sistered" and otherwise re-supported/patched. The trusses may have been site built by the builder as opposed to being designed by an engineer and built by a truss manufacturer. Trusses should not be modified without special engineering of additional support. This area should be monitored. Any further movement warrants a consult with a qualified licensed structural engineer.

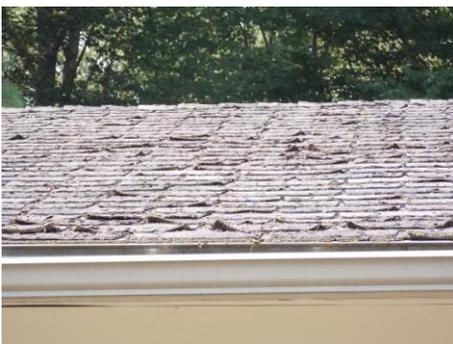
Sloped Roofing

- **Major Concern:** The Composition Shingle roofing on the carport is at end of its life and should be replaced. Curling, bubbling (especially at the edge of the shingles), loss of particulate and some missing roofing material were noted. These conditions are a normal sign of age and brittleness of the shingles. A qualified experienced roofing contractor should perform this work.

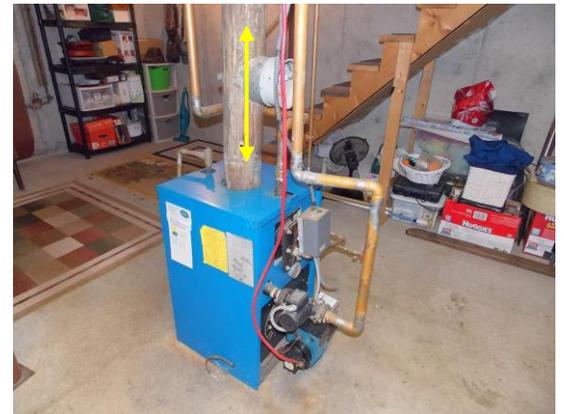
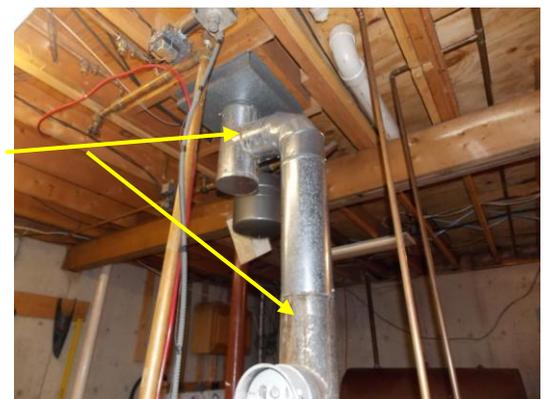
Flue

- **Monitor:** Corrosion was noted on exhaust flue piping. New piping was noted. This is an indication of problems with efficient exhaust of flue gasses. This condition has been known to allow flue gasses into the home and/or to allow condensate to corrode a heater beyond repair. Further investigation by a heating specialist is recommended.

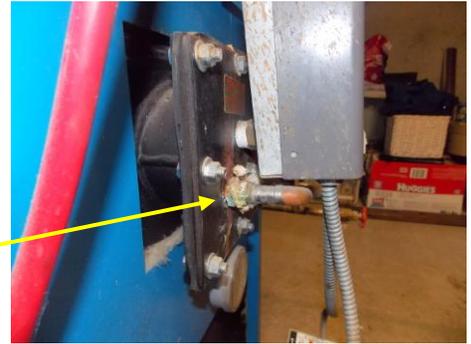
Boiler

- **Deferred Cost:** Based on its age, the boiler may be near the end of its useful life. Budget for a new boiler; this is a significant expense.
- **Improve:** A low water cut off control was not found. This item helps safeguard the boiler in event of a boiler leak.
- **Repair:** A serious amount of corrosion from a leak was observed at the hot tap water coil. This can be especially problematic for steel boilers. A heating technician should be engaged to remedy this condition.

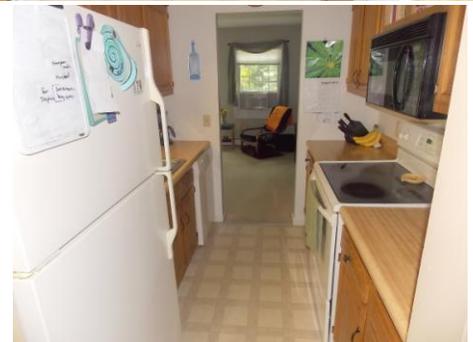
Kitchen Cabinets

- **Repair:** Shelf supports are inadequate in a few wall cabinets. They should be installed where needed. A qualified experienced carpenter can perform this work.

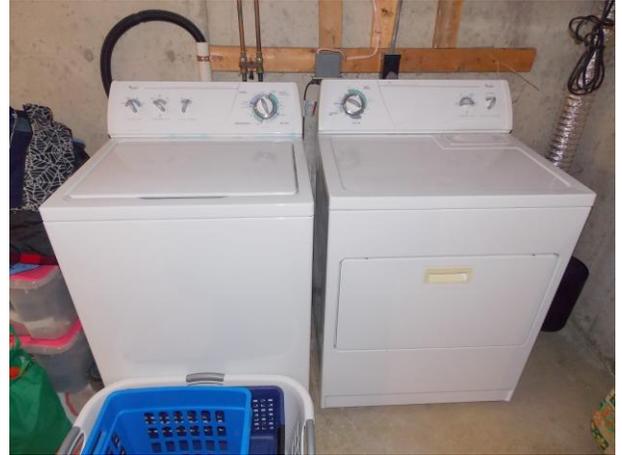
Clothes Washer

- **Repair:** The operation of the clothes washer is suspect. It would not continue past fill cycle today. Further review by a service technician is recommended.
