# Building Inspection Report

\_\_\_\_\_, Suburban, VT

**Inspection Date:**  
5/7/2010

**Report Number:**  
4261.0510

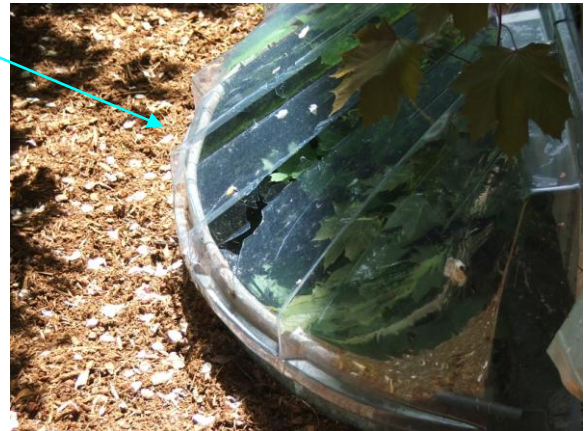
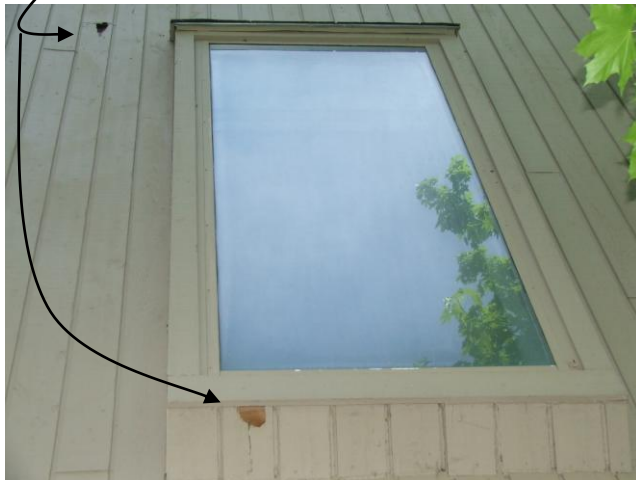
- **Repair:** Damage to the north wall is suspected to be the result of vermin activity. Repairs are needed. Depending on the nature of the vermin activity, consulting an animal control specialist may be desirable.

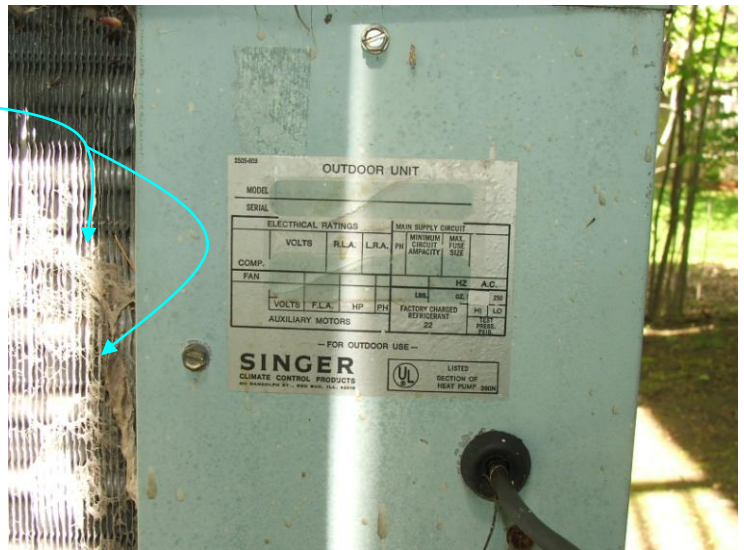
- **Safety Issue:** The fan is easily accessible from the back side. Someone could be badly injured from this. Recommend a protective grate be installed before use.

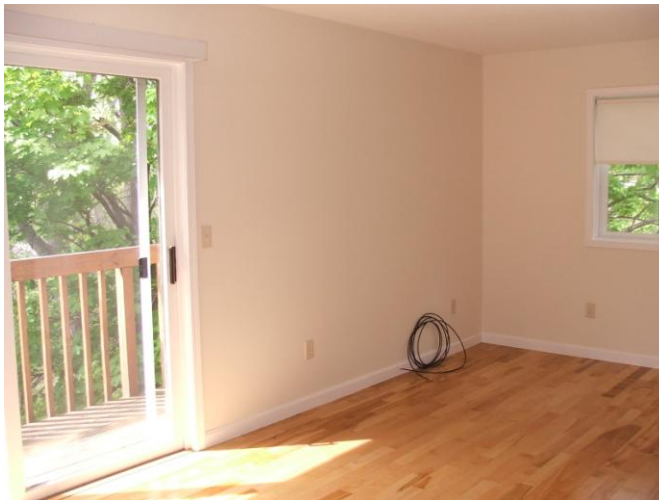
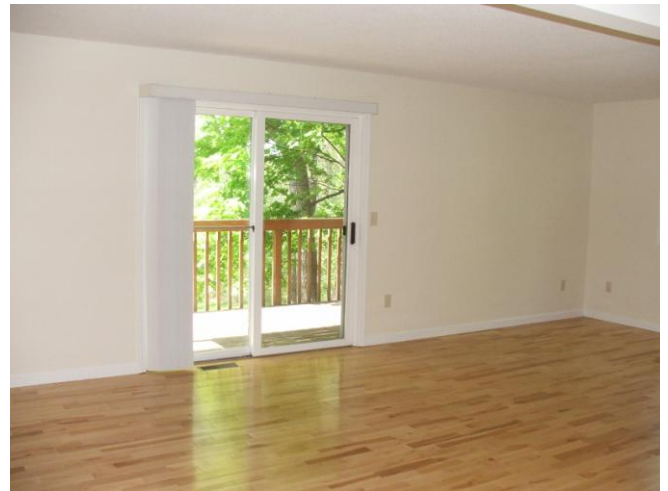
The majority of the windows are good quality. The majority of the doors are average quality. The windows have, for the most part, been well maintained. A sample of windows and doors were opened and seemed to operate freely. No rotted parts or inoperable hardware was noted in the windows that were opened. No fogged glass was observed. with exception of two windows.

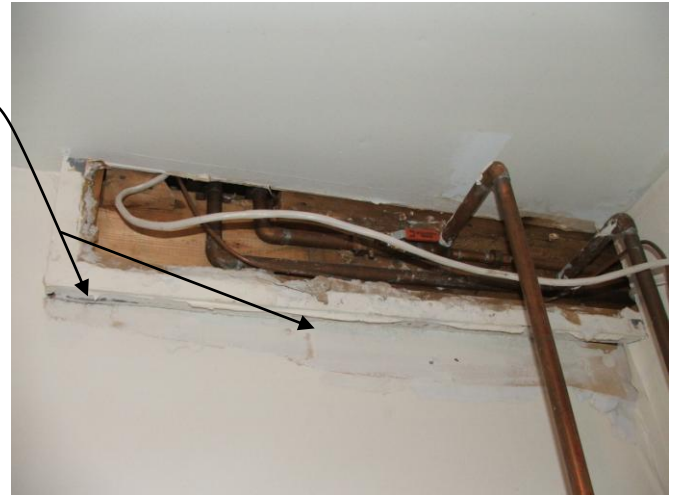
- **Improve:** The walls in the laundry show evidence of water damage. This condition is suspected to be the result of a plumbing leak. The stains were dry today. The seller of the home reports that this condition is the result of a one-time roof leak. It is further reported that this is not an ongoing problem. Recommend patching, sealing, painting and monitoring.
- **Monitor:** Larger than typical cracks were noted in the 3<sup>rd</sup> floor ceiling. This is a condition called truss lift. It may become more pronounced in winter. This condition is considered cosmetic and can be corrected. Recommend monitoring.

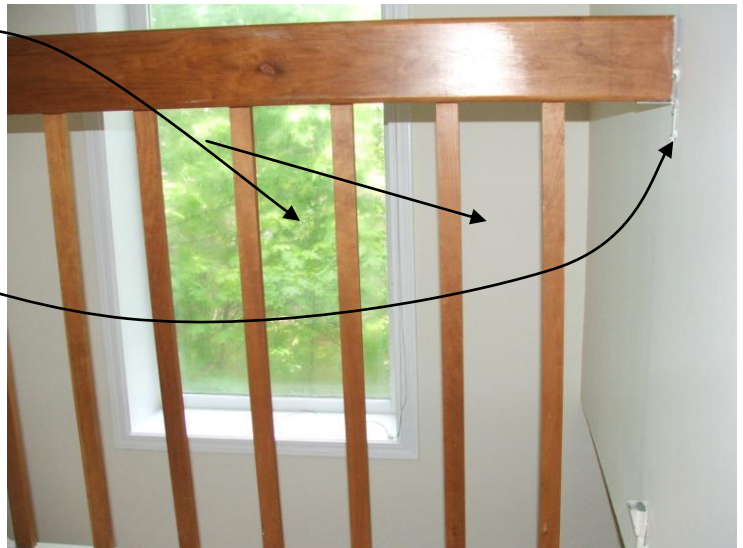
- **Repair, Safety Issue:** The openings in the stairway railings are large enough to allow a child to fall through. In addition, the rail is loose from the wall. It is recommended that this condition be altered for improved safety.
