Building Inspection Report

_____, Essex Junction, VT

Inspection Date:
1/8/2010

Report Number:
4182.0110

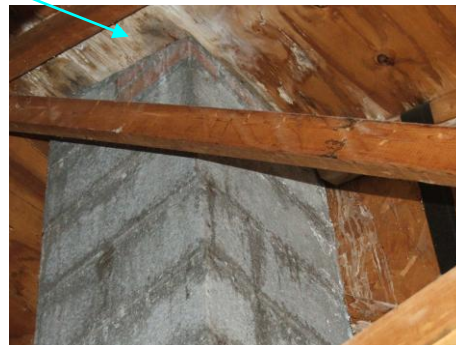
- **Monitor:** The roof sheathing shows staining in particular around the chimney. This condition is suspected to be the result of roof leakage and/or leakage from ice damming on the roof. These stains are likely from leakage episodes through the years. Given the roofing is new, it is unlikely that anything other than driving rain or snow melt would produce water stains - not from 'normal' rain. The stains were dry today. Recommend monitoring. A qualified roofing contractor should be consulted to review flashing details should leaking occur.
- **Repair:** Evidence of condensation (in the form of mildew) was observed on the underside of the roof sheathing. This can weaken the sheathing and ultimately necessitate replacement. Improved insulation and attic ventilation can reduce condensation. See also **Insulation / Ventilation** – page ???;

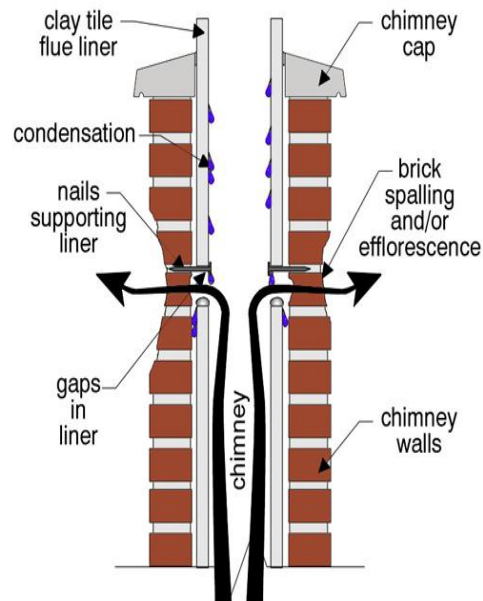
Chimney deterioration due to condensation

even lined chimneys can suffer from condensation related brick damage (particularly if the flue liner has gaps in it)

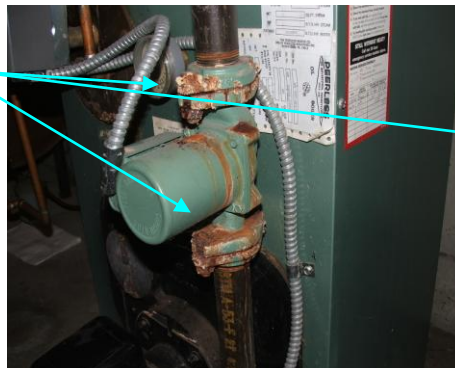
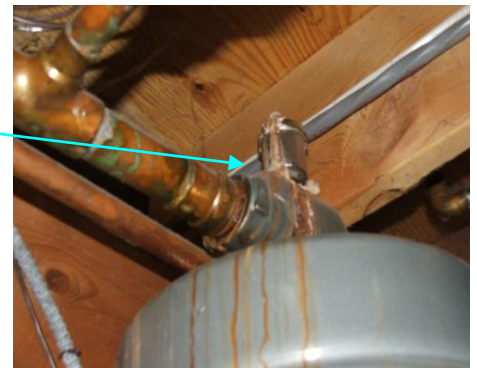
- **Repair:** A leak was observed at the circulation pump, on the air vent and on the hot tap water coil. Leaks at heating equipment should be repaired promptly to avoid damage to the equipment or to the building and to assure reliable system operation.

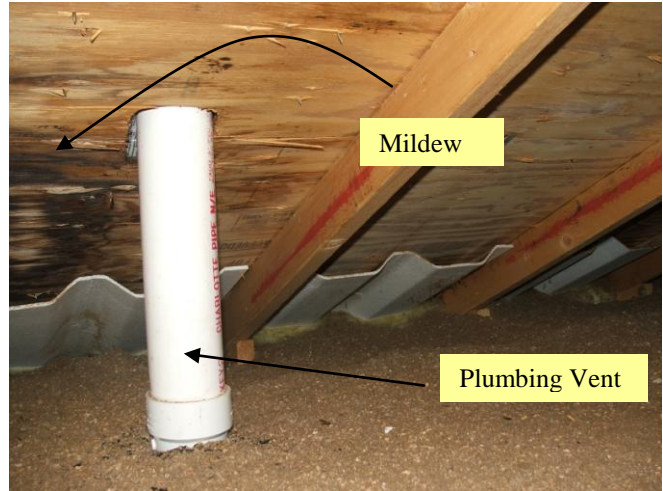
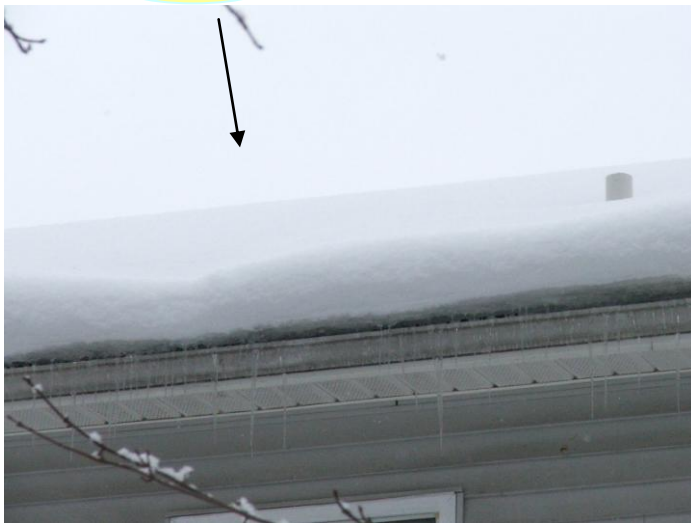
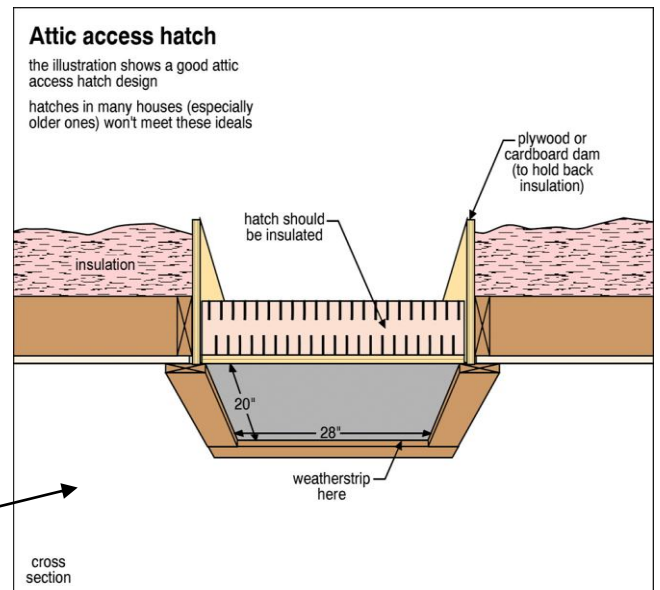
- **Improve:** The insulation vapor barrier is missing in the main attic where checked – over the bathroom. A moisture meter showed elevated dampness in the plywood in this spot. Evidence of condensation and mildew was observed. This condition is usually the result of insufficient insulation and ventilation. A vapor barrier should be complete and applied to the warm side. Recommend a qualified builder or insulation specialist can help correct and improve this detail.
- **Repair:** The bathroom exhaust vent pipe (under the insulation) should be vented to the building exterior. It is suspected to be emptying into the exterior soffit and consequently flowing back into the attic space. This would account for the damp, mildewed plywood and the heat loss as seen from the exterior.

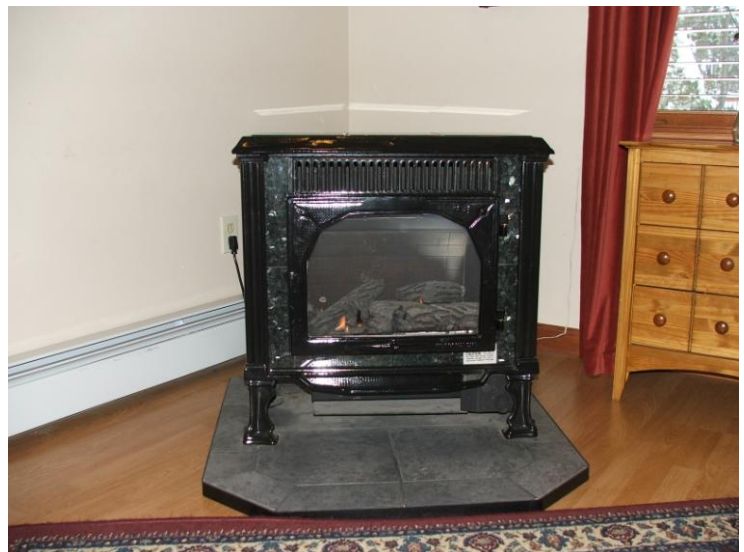
- **Safety Issue:** The glass of the fireplace will get too hot to touch. Carelessness here will result in a serious burn. Recommend providing a screen for this area. Families with children should be especially aware of this.
