Building Inspection Report

-----, Burlington, VT

Inspection Date:
12/16/2010

Report Number:
4358.1210

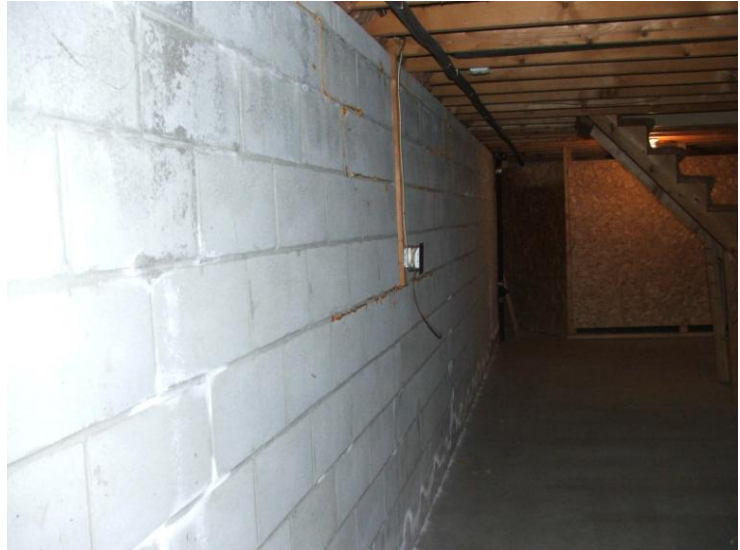
- **Monitor:** Foundation bowing and cracking was observed on all walls. This is usually the result of excessive soil or frost pressure on the foundation. Lot drainage and foundation improvements should be addressed to keep water away from the

building, and these cracks should be monitored. The rate of movement cannot be predicted during a one-time inspection. If these cracks should worsen, a structural engineer or qualified foundation repair contractor should be consulted to assess this condition and the remedies available for correction.

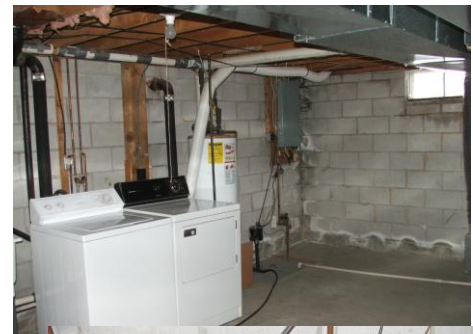
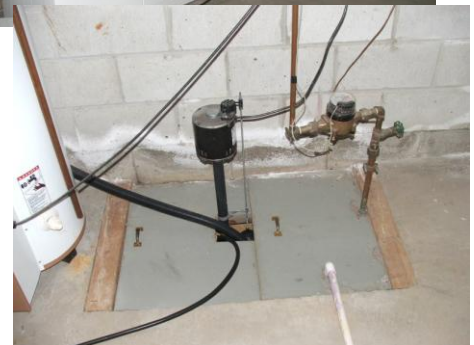
- **Monitor:** The basement shows evidence of moisture penetration evidenced by: / Staining / efflorescence / installation of a sump pump . It should be understood that it is impossible to predict the severity or frequency of moisture penetration on a one-time visit to a home.

- **Monitor:** Proper performance of the sump pump is helpful in preventing basement flooding. Sump pumps usually serve to discharge storm water from the perimeter foundation drainage tiles. In this case, it will only take out some water that may have gotten in and it lowers the water table in the immediate vicinity of the pump. If the sump pump becomes inoperative, or if the discharge line is broken, damaged or improperly sloped, flooding can result. The operation of the sump pump should be carefully monitored. If the sump pump operates regularly, it may be prudent to consider a back up pump, or a battery power supply in the event of a power interruption. Additionally, an ice guard should be included for the drain pipe. Please refer to the "Plumbing" section, where there may be more information on the sump pump. (Note: It is usually not possible to verify the discharge location of the sump pump line during an inspection.)

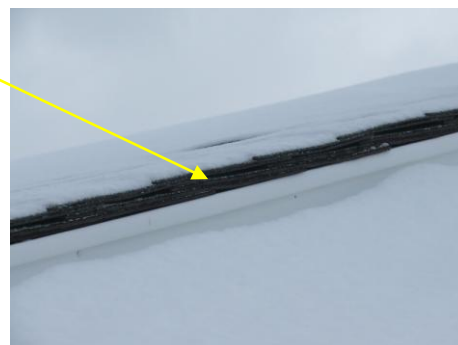
- **Monitor:** The application of two layers of asphalt composition shingles is less than ideal. The result is usually a shortened lifespan. Other problems such as difficulties with flashing around penetrations through the roof and lifted shingles can occur. Recommend monitoring.
- **Monitor:** The roofing is in good condition. It shows evidence of moss and organic build up. This condition may reduce the life expectancy of the roofing. Cleaning is sometimes possible. Consult an experienced Roofing Contractor.

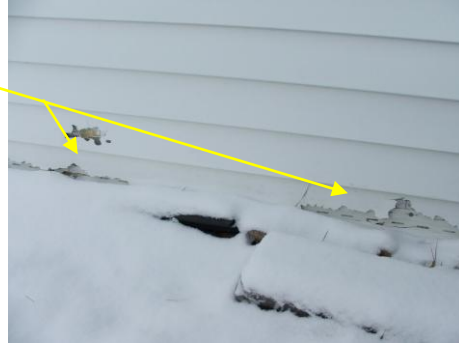
- **Repair:** Damaged/cracked siding at the rear wall should be repaired or replaced. A qualified experienced carpenter should perform this work.
- **Repair:** The loose siding at the rear wall should be re-secured to avoid more wind-damage.
- **Repair:** The insulation along the base of the building lacks a drip edge. This detail keeps water from getting behind the trim that, in turn can cause rot to the sheathing and house frame. A qualified experienced carpenter should be consulted.

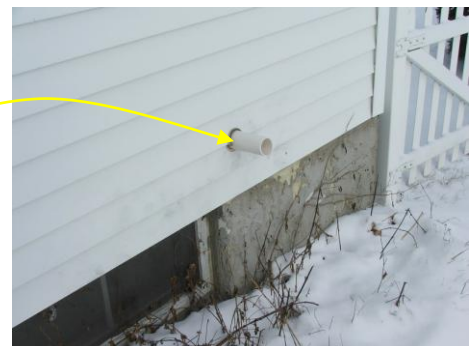
- **Monitor:** The exterior vent for the heating system should be monitored for any blockage (snow, etc.). A malfunction in this system could spill dangerous flue gases into the home.
- **Repair, Safety Issue:** The exhaust vent should turn down on the exterior ads per manufacturers recommendations. In this case, it may be too close to the basement window. This condition should be evaluated by a qualified licensed heating technician.
