Building Inspection Report

_____, South Burlington, VT

Inspection Date:
2/14/2008

Report Number:
----- .208

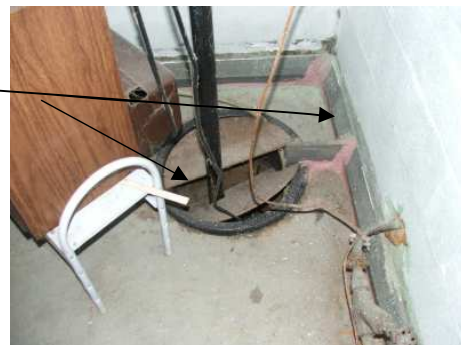
- **Monitor:** No evidence of moisture penetration was visible in the basement at the time of the inspection. *It should be understood that it is impossible to predict whether moisture penetration will pose a problem in the future.* The vast majority of basement leakage problems are the result of insufficient control of storm water at the surface. Think of the home as sitting on top of the Pitcher's mound in Baseball. The ground around the house should be sloped to encourage water to flow away from the foundation. Gutters and downspouts should act to collect roof water and drain the water at least five (5) feet from the foundation or into a functional storm sewer. Downspouts that are clogged or broken below grade level, or that discharge too close to the

foundation are the most common source of basement leakage. Please refer to the Roofing and Exterior sections of the report for more information.

In the event that basement leakage problems are experienced, lot and roof drainage improvements should be undertaken as a first step. Excavation, damp-proofing and/or the installation of drainage tiles should be a last resort. In some cases, however, it is necessary. Your plans for using the basement may also influence the approach taken to curing any dampness that is experienced.

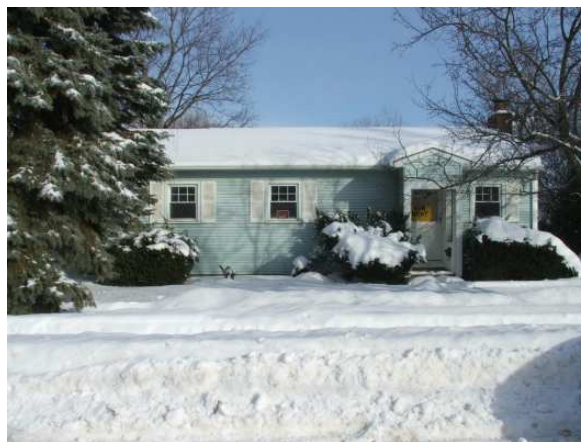
The roof was covered with snow today. What I could see of the roof covering was in good condition. No active roof leaks were noted from the underside of the roof sheathing observed or from interior surfaces observed. **I recommend another look at this roof once it is clear of snow.** The chimney does not show signs of significant deterioration. A rain cap and vermin screen has been installed on one of the masonry flues.

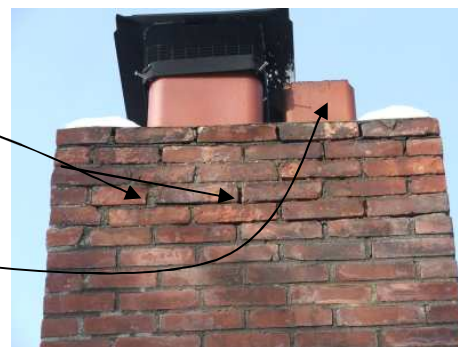
- **Repair:** The masonry chimney(s) should be swept and inspected by a qualified chimney sweep before use. Have the Chimney Sweep check for any damaged flue tiles. Relining a chimney can be relatively expensive. **See also Heating – Page 14**
- **Improve:** The masonry chimney shows evidence of spalling (surface deterioration of the masonry). **Repair is not necessary at this time but this condition should be monitored.**
- **Improve:** A rain cap and vermin screen could be installed on the right hand flue. The cement cap should be checked by the chimney sweep at this time, as deterioration and cracking is a common condition of this component

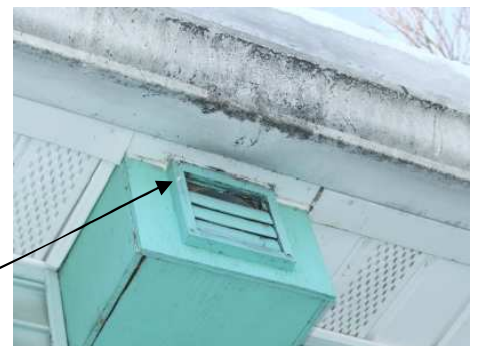
- **Improve:** Damaged/cracked siding in a few locations should be repaired or replaced. A qualified experienced carpenter should perform this work.
- **Monitor:** Wood/soil contact at the base of the siding should be eliminated on the garage. Rotted or damaged siding that is uncovered should be repaired. These areas are at risk of additional hidden damage.
- **Repair:** A damaged exhaust vent was observed at the east side of the home. It should be repaired and protected against vermin entry.

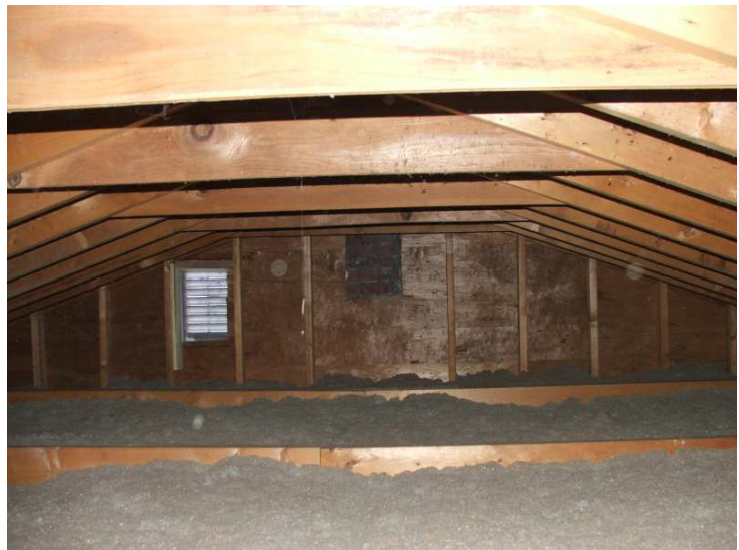
- **Improve:** Ideally, the attic access hatch should be better insulated and weather-stripped. A fair amount of heat is lost through this type of opening.

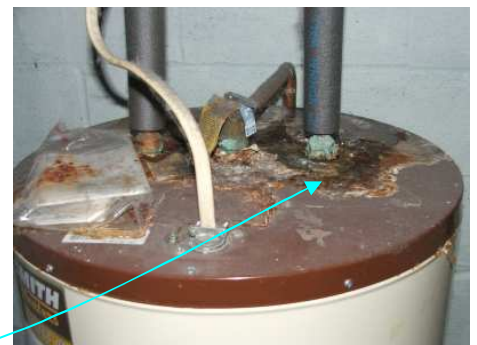
- **Major Concern:** The water heater did show serious corrosion and leaking. Expect to have top replace this unit. **Page 18**

- **Major Concern:** After turning on most available faucets and for 15+-minutes at the kitchen faucet, the water heater produced hot water today. It did show serious corrosion and leaking. Expect to have top replace this unit. A qualified licensed plumber should perform this work.

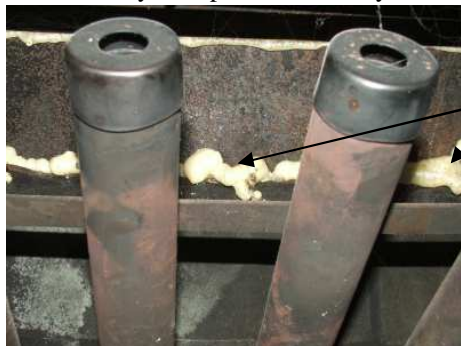
- **Improve:** The fireplace chimney should be swept and inspected by a qualified chimney sweep prior to operation.
- **Monitor:** The damper was sealed shut with foam. The chimney sweep should remedy this.

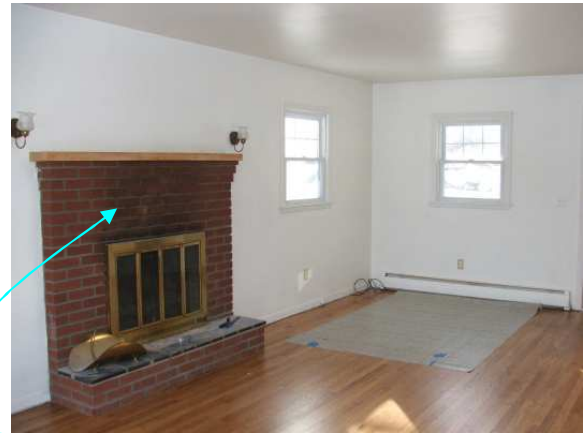
- **Monitor:** The fireplace shows evidence of

having a poor draft. There are a number of improvements that can be undertaken to alter this condition (if it proves to be a problem). In some cases, it is not cost effective to improve the draft, and glass doors are installed to contain the smoke within the firebox.

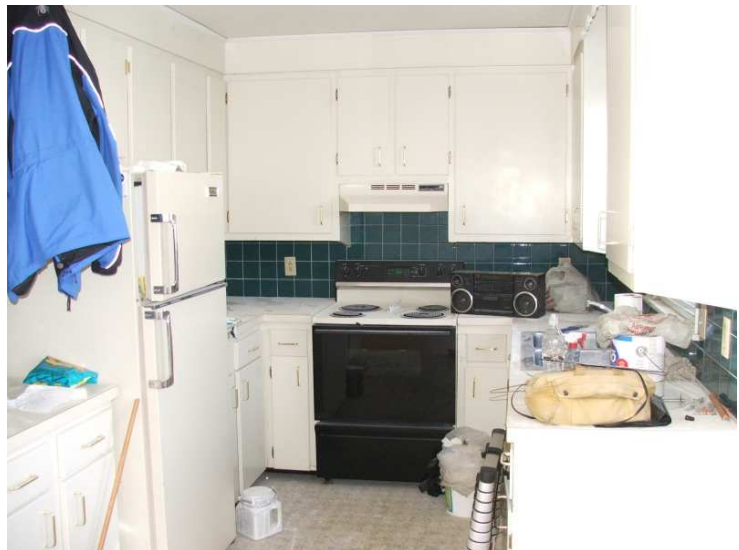
- **Potential Safety Issue:** An anti-tip device could not be seen behind the oven. One should be installed according to the manufacturers directions. This will reduce the risk of tipping of the appliance from abnormal usage or by excessive loading of the oven door.
- **Safety Issue, Repair:** The electric range top is lower than the counter. This can burn the counter. It should be adjusted up according to the manufacturer recommendations. A qualified appliance repair technician should perform this work.

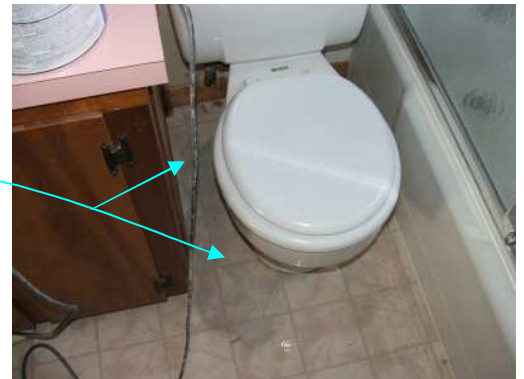
- **Repair:** The toilet is loose. This can lead to leaking and further problems. Recommend a qualified plumber secure it.
- **Monitor:** The toilet shows evidence of prior leakage.
- **Monitor:** The sink traps are aging/corroding so that they will develop leaks. Expect to replace these.
- **Repair:** The window and sill of the bathtub enclosure should be protected from moisture. A waterproof curtain is usually sufficient. Windows in bathtub enclosures have a reputation for allowing leakage behind the enclosure, causing damage to the wall.
