# Building Inspection Report

Shelburne, VT

**Inspection Date:**  
4/4/2007

**Report Number:**  
3682.407

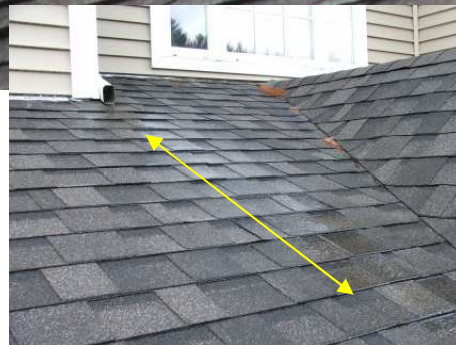
- **Improve:** Downspout(s) that discharge onto the roof should be extended to discharge directly into the gutters below. This condition, if left unattended, can result in premature deterioration of the roofing under the end of the downspout.
- **Repair:** The downspout(s) should discharge water at least five (5) feet from the house. Storm water should be encouraged to flow away from the building at the point of discharge. [See also Exterior – page 10](#)

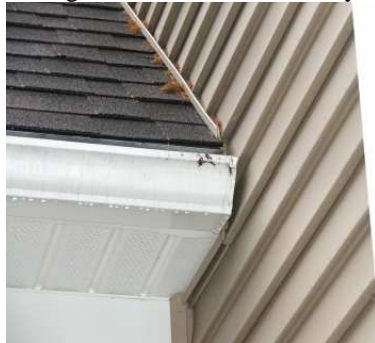
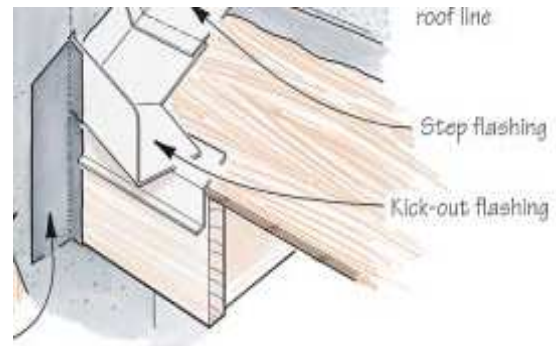
- **Monitor:** The roof/wall (step) flashing does not include a 'kick out' detail at the bottom. A qualified experienced carpenter or roofing contractor should, ideally, install one.

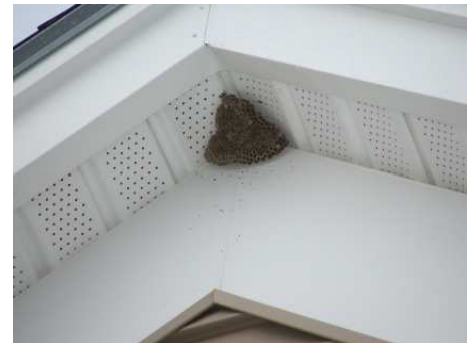
- **Repair: Safety Issue:** Bee nests were noted at the front wall. A qualified exterminator should be consulted.

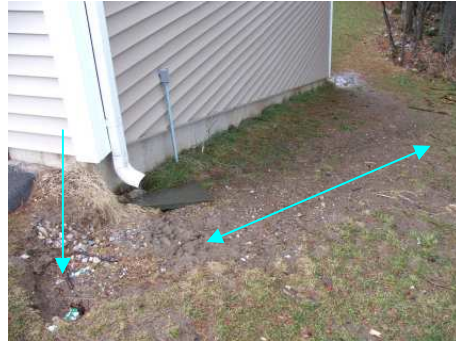
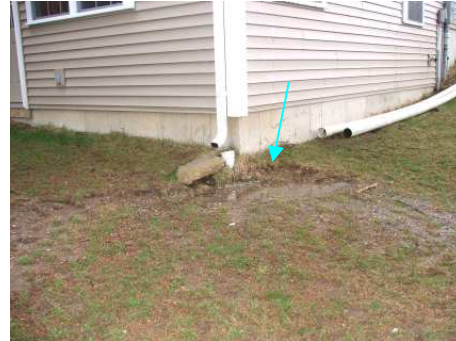
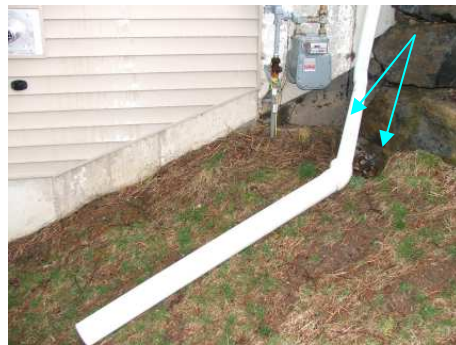
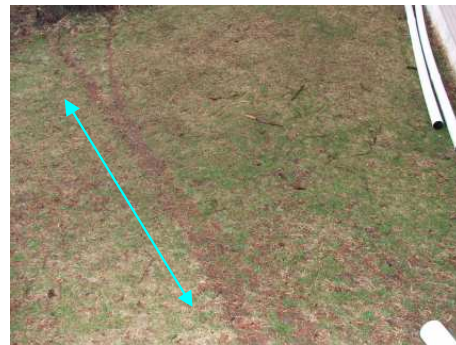
- **Repair:** Soil is eroding/washing away in various locations. Controlling runoff water and re-grading is recommended. A qualified experienced landscape contractor can perform this work. See also **Roofing – rain gutters**.

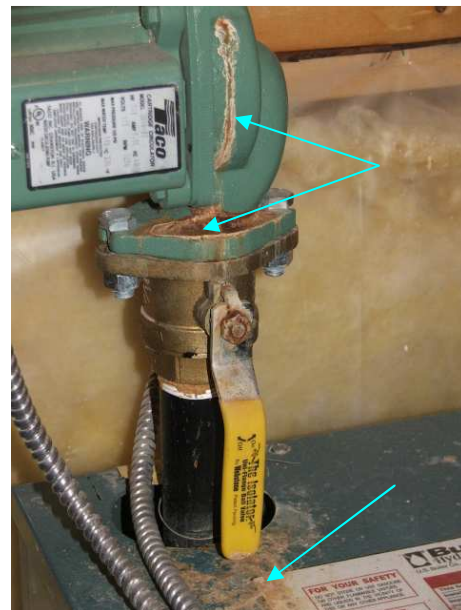
- **Monitor: Improve:** An Electric Firmatic control should be installed unless this unit has one already ‘built in’. A heating technician should be consulted.
- **Improve:** There was a noticeable quantity of dust visible in the gas boiler. These deposits are not unusual but can be an indication of lack of periodic cleaning and maintenance. A tag on the boiler warns against letting dust accumulate.
- **Monitor:** The boiler shows evidence of prior leakage on the circulation pump. Watch for and repair any leaks promptly as prolonged leakage can damage the boiler.

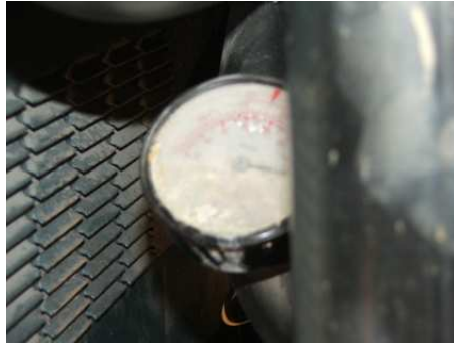
- **Repair:** A leak has damaged the boiler gage. **Page 15**
- **Repair:** Soil is eroding/washing away in various locations. **Page 10**
- **Repair:** The electric system revealed the need for a few improvements. **Page 12**

- **Repair:** A leak has damaged the gage. Leaks at heating equipment should be repaired promptly to avoid damage to the equipment or to the building and to assure reliable system operation.

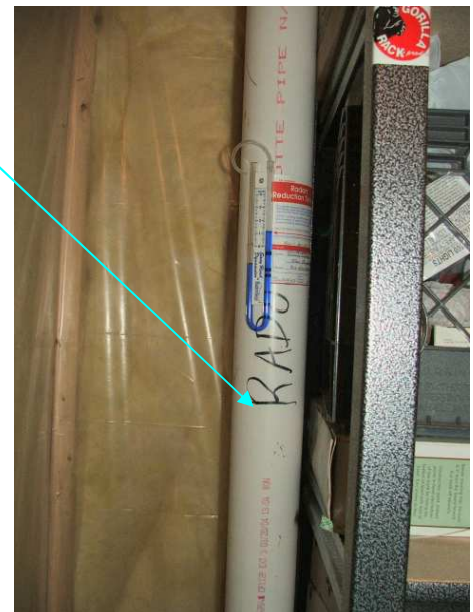
- **Improve:** Air quality could probably be improved by making more formal use of the air exchange system. Fans were operating but no provision for make-up air was seen. Recommend an audit by an Energy/Environment contractor.
- **Monitor:** Basement piping shows that a radon reduction system has been added in this area. The presence of an attic fan was not confirmed. See Limitations

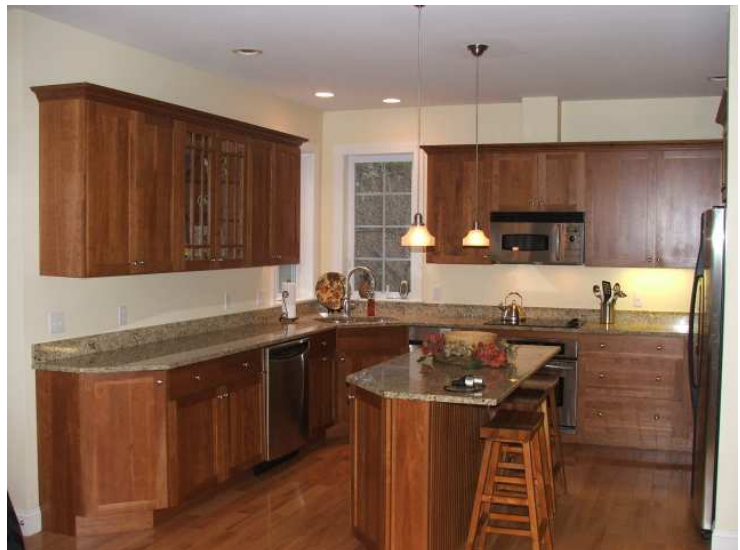
- **Monitor:** The refrigerator ice dispenser did not operate. It may be turned off.
