Building Inspection Report

-----, VT

Inspection Date:
08/07/2013

Prepared By:
Burlington Home Inspection Service Ltd.
137 Mansfield Ave.
Burlington, VT 05401

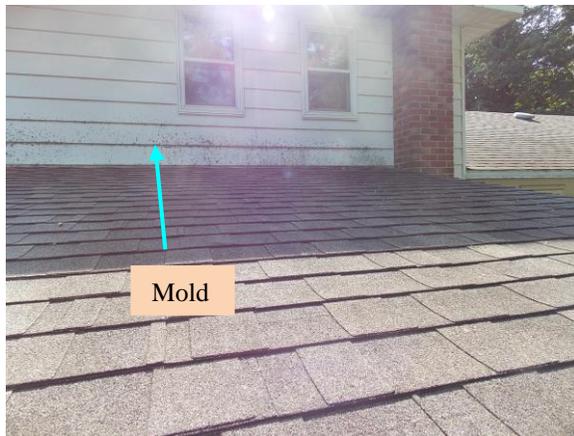
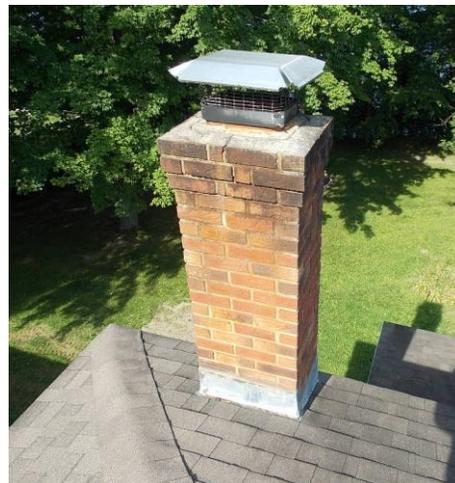
West Chimney

- **Repair:** The masonry chimney(s) should be swept and inspected by a C.S.I.A. certified chimney sweep before use. Have the Chimney Sweep check for any damaged flue tiles. Relining a chimney can be relatively expensive. No obvious cracks were seen when viewed with a mirror from the cleanout or the fireplace.
- **Monitor:** The chimney at the west slope is no longer in service. It could be removed.
