Building Inspection Report

----- Road, Essex, VT

Inspection Date:
11/05/2011

Prepared By:
Burlington Home Inspection Service Ltd.
137 Mansfield Ave.
Burlington, VT 05401

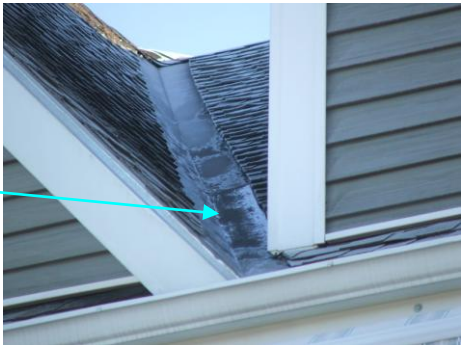
The design of the roofing system is such that a vulnerable areas exists at the rear slope. There is a higher potential for snow build up and related leaks. Annual inspections and ongoing maintenance will be critical to the performance of the roofing system.

- **Repair:** Rippled areas were noted on the rear return roof. This is suspected to be from warped sheathing. This, in turn is likely from the dryer venting into the return. Moisture damage could be present. recommend further investigation and any repairs deemed necessary. See also **Flashings** – below; **Dryer** - page 26 and **Exterior Eaves** - page 11

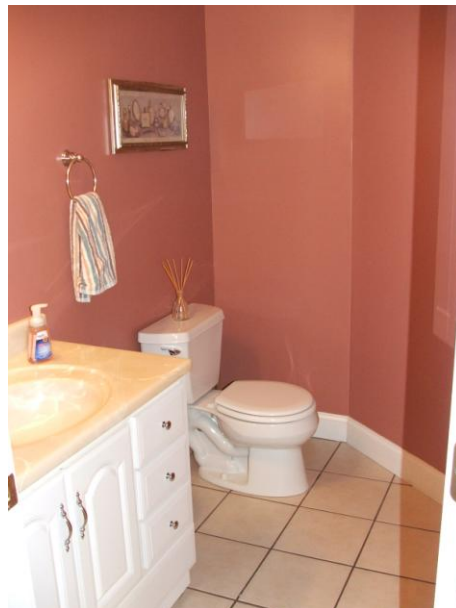
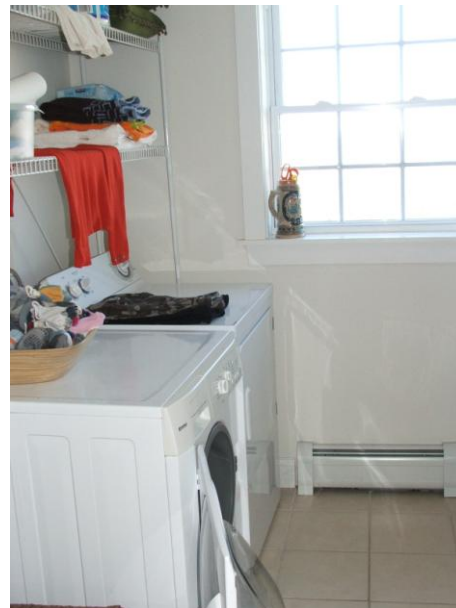
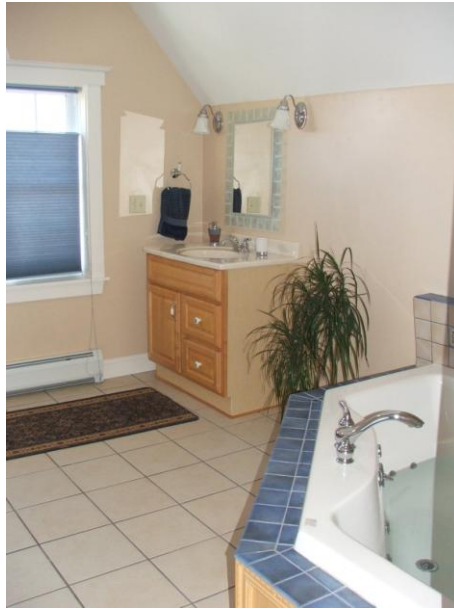
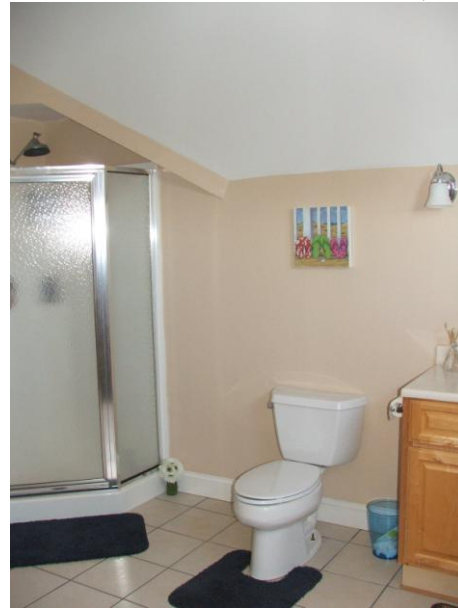
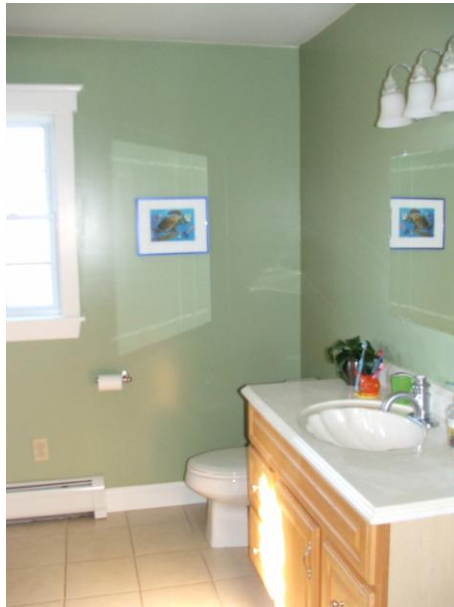
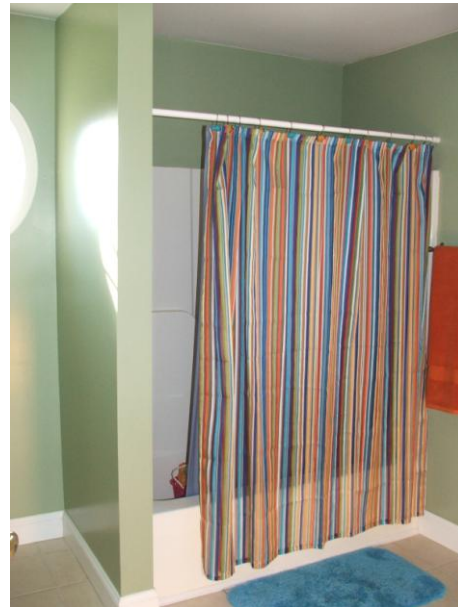
Minor repairs are needed.
