Building Inspection Report

----- **Essex, VT**

Inspection Date:
08/19/2013

Report Number:
-----.0813

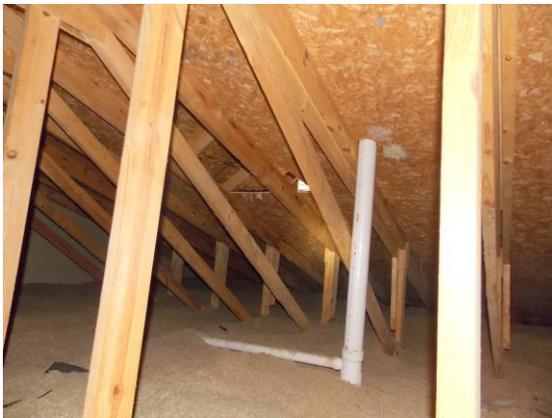
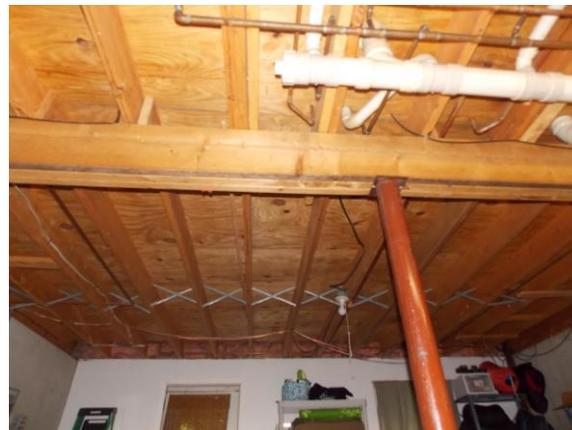
- **Monitor:** Some roof sheathing sags. This is common where roof trusses are spaced two feet apart, allowing sagging between trusses.
- **Monitor:** Prior repairs to the roof structure are evident. Roof trusses have been altered. They have been "sistered" and otherwise re-supported/patched. The trusses may have been site built by the builder as opposed to being designed by an engineer and built by a truss manufacturer. Trusses should not be modified without special engineering of additional support. This area should be monitored. Any further movement warrants a consult with a qualified licensed structural engineer.
