# Building Inspection Report

\_\_\_\_\_, Suburban, VT

**Inspection Date:**  
5/7/2010

**Report Number:**  
4261.0510

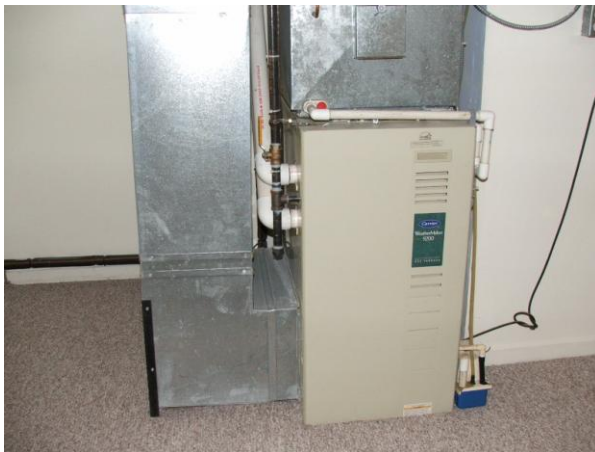
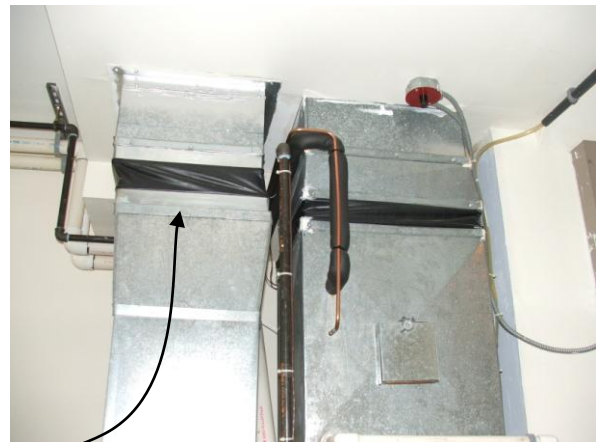
The central heating system appears in generally good condition. Heat distribution within the home appears adequate. This is considered a high efficiency heater. An automatic shut off device was noted for electricity to the unit. The boiler was determined to be middle aged as read on the information plate The expected lifespan for this type of unit is 20+- Years. It operated quietly, heated up, and distributed hot water throughout the activated zones as expected. No leaks were detected in the baseboard heaters.

Anti-vibration collars are installed on the plenums (large ducts above the furnace). The flue connections were secure and the clearances as observed seemed reasonable. The flue has a fan assist. This is an important safety consideration for a heating system of this type and eliminates the need for a chimney for this appliance. The burner gets its own combustion air from an intake flue – increasing efficiency.
