Building Inspection Report

_____, Essex Junction, VT

Inspection Date:
1/8/2010

Report Number:
4182.0110

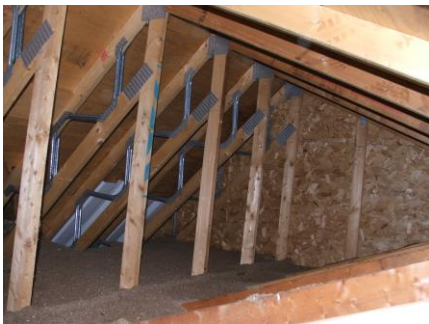
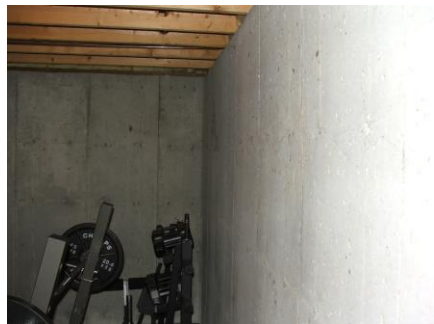
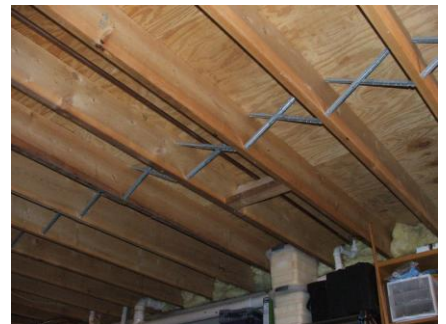
The spans of all observed joists and rafters appear to be within acceptable limits and no appreciable movement was noted when floors were 'bounced upon'. They were observed to be clean and free of rot with only minor, typical cracks. The carrying beams and support columns were reasonably straight and in good condition with no significant rust or rot. The exterior plane of the roof was even and flat.

The foundation walls were straight and even. No serious cracks or bulges were noted in the observed walls. Ample ground clearance from wood sills and trim was noted.

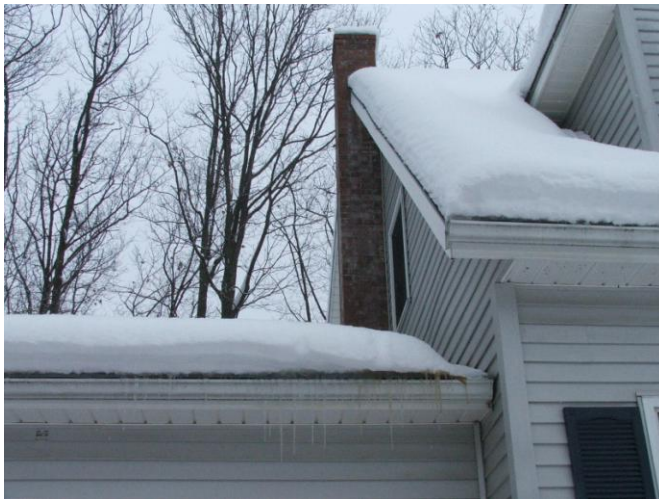
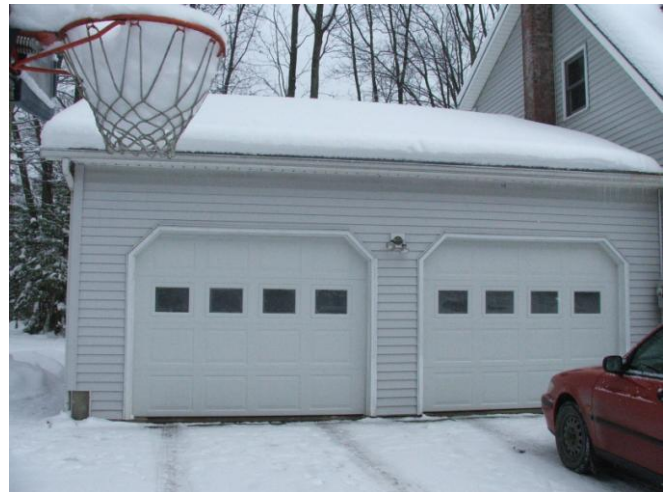
The roof was covered with snow today. What I could see of the roof covering was in good condition. No active roof leaks were noted from the underside of the roof sheathing observed or from interior surfaces observed. I recommend another look at this roof once it is clear of snow. This material is reported by the owner to be 3+- years old.

A plumbing vent pipe was observed to penetrate the roof at normal height and in good condition. The chimney does not show signs of significant deterioration.

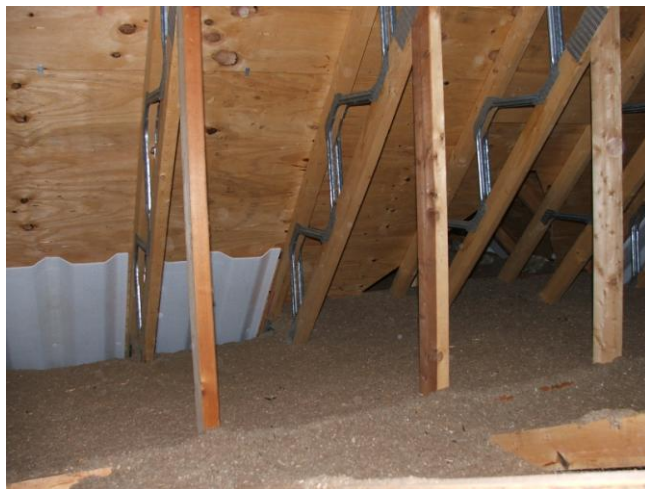
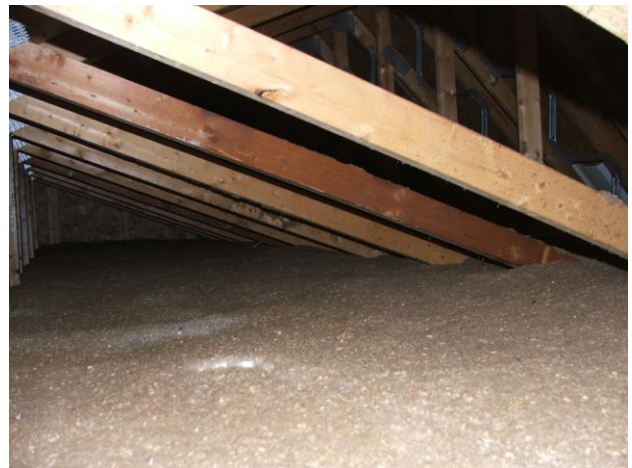
Insulation levels are typical for a home of this age and construction. No mildew or rot was noted on the underside of the roof sheathing. Based on the insulation seen and the evidence of insulation seen, this can be considered a moderately well insulated home.
