Building Inspection Report

-----, Burlington, VT

Inspection Date:
12/16/2010

Report Number:
4358.1210

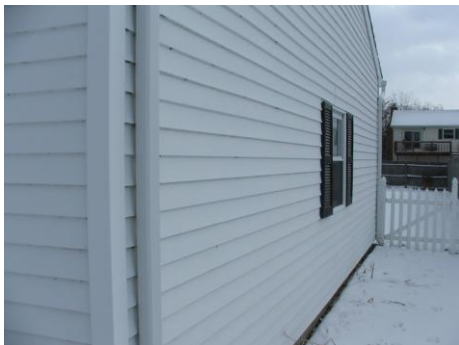
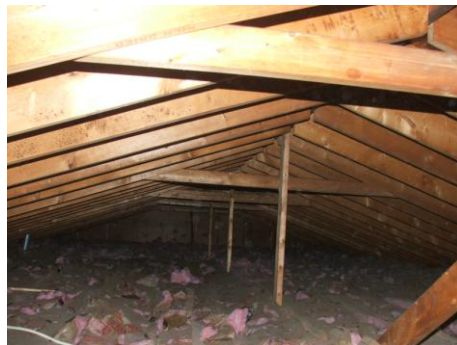
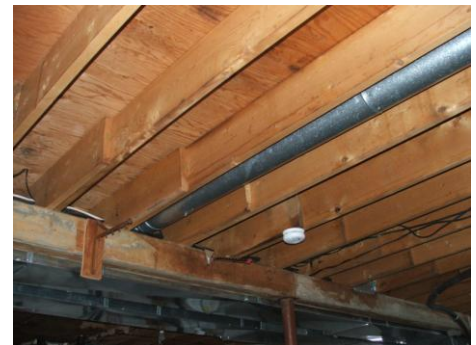
The spans of all observed joists and rafters appear to be within acceptable limits and no appreciable movement was noted when floors were ‘bounced upon’. They were observed to be clean and free of rot with only minor, typical cracks. The carrying beams and support columns were reasonably straight and in good condition with no significant rust or rot. The exterior plane of the roof was even and flat.

The foundation walls appear, for the most part, straight and even. Ample ground clearance from the wood structure and trim was noted. The basement floor slab observed is in good condition – flat and even. It has typical cracks usually the result of shrinkage and/or settling of the slab.

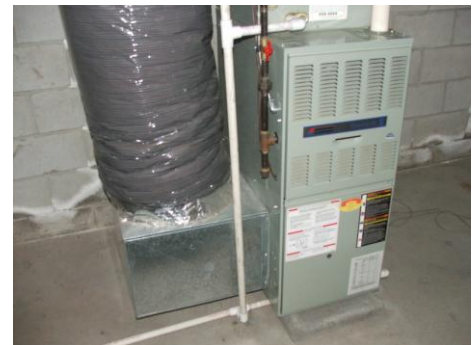
Upward pitch was noted on the flue pipe. The flue connections were secure and the clearances as observed seemed reasonable. The flue has a fan assist. This is an important safety consideration for a heating system of this type and eliminates the need for a chimney for this appliance.

The furnace requires service by a qualified, professional heating technician before use and every year thereafter. This should be a regular maintenance item to assure safe, reliable heat. The heating system shows no visible evidence of major defects. Minor repairs to the heating system are necessary.

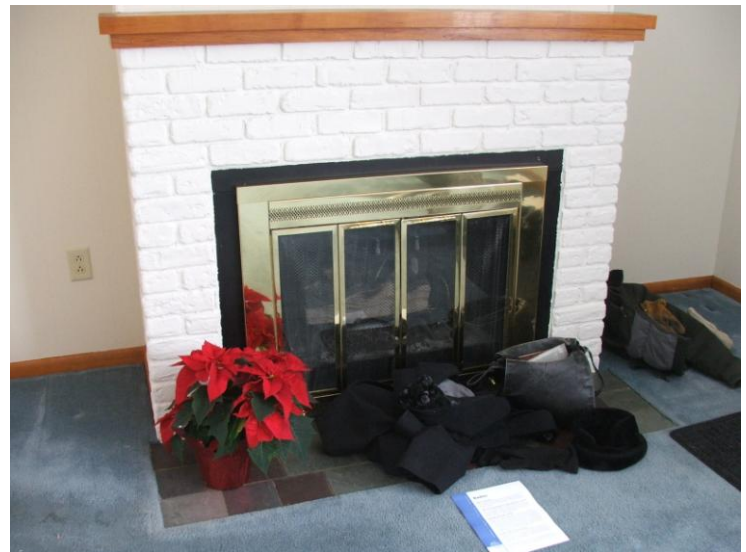
On the whole, the fireplace and its components are in good condition. The wood surrounding mantelpiece was well attached and in good condition. The brick surrounding wall/mantelpiece was well attached and in good condition. The tile hearth and trim was good. Joints were reasonably tight. No cracks were noted.
