# Building Inspection Report

Shelburne, VT

**Inspection Date:**  
4/4/2007

**Report Number:**  
3682.407

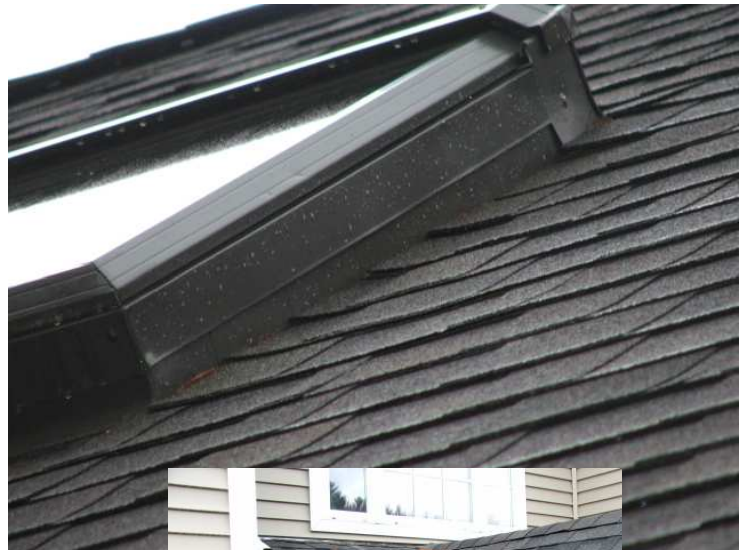
The composition shingle roofing on the entire house is considered to be in good condition. The shingles are, for the most part, bright with even, square corners and laying flat. No missing or damaged shingles were noted. You should expect several years of performance from this roof covering. This material is reported by the owner to be 2+- years old.

No active roof leaks were noted from interior surfaces observed. A plumbing vent pipe was observed to penetrate the roof at normal height and in good condition. Roof flashing details appear to be in good order. The installation of the roofing materials has been performed in a professional manner. Installation details look neat and trim.

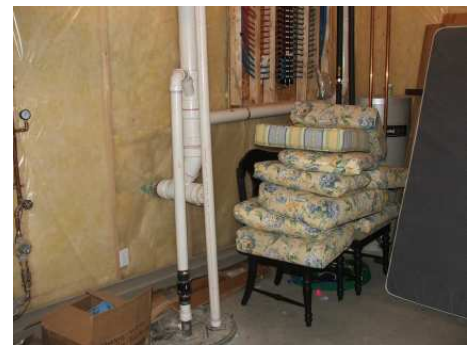
The water heater is a relatively new unit. No rust/corrosion or water was observed at the base of the unit. Hot water was produced after turning on all designated faucets and for 10 minutes in the kitchen. As the typical life expectancy of water heaters is 9 to 14 years, this unit should have several years of remaining life. Connections were tight and no serious corrosion was seen. The water heater temperature should be set such that accidental scalding is minimized. Families with small children should be especially aware of this.
